Severe damage to Manchester Courts

By Jason Ingham and Michael Griffith

Overview

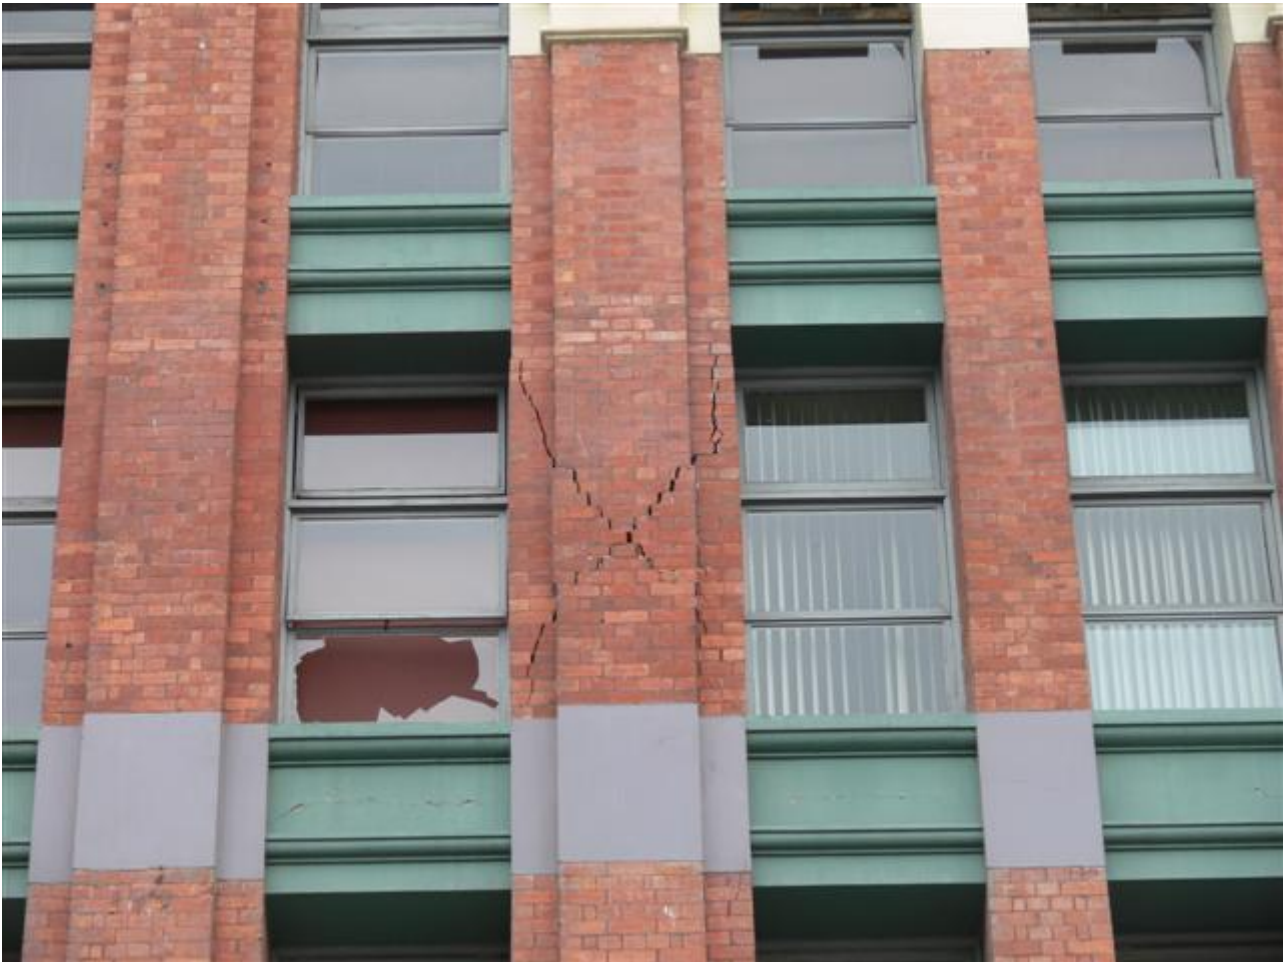
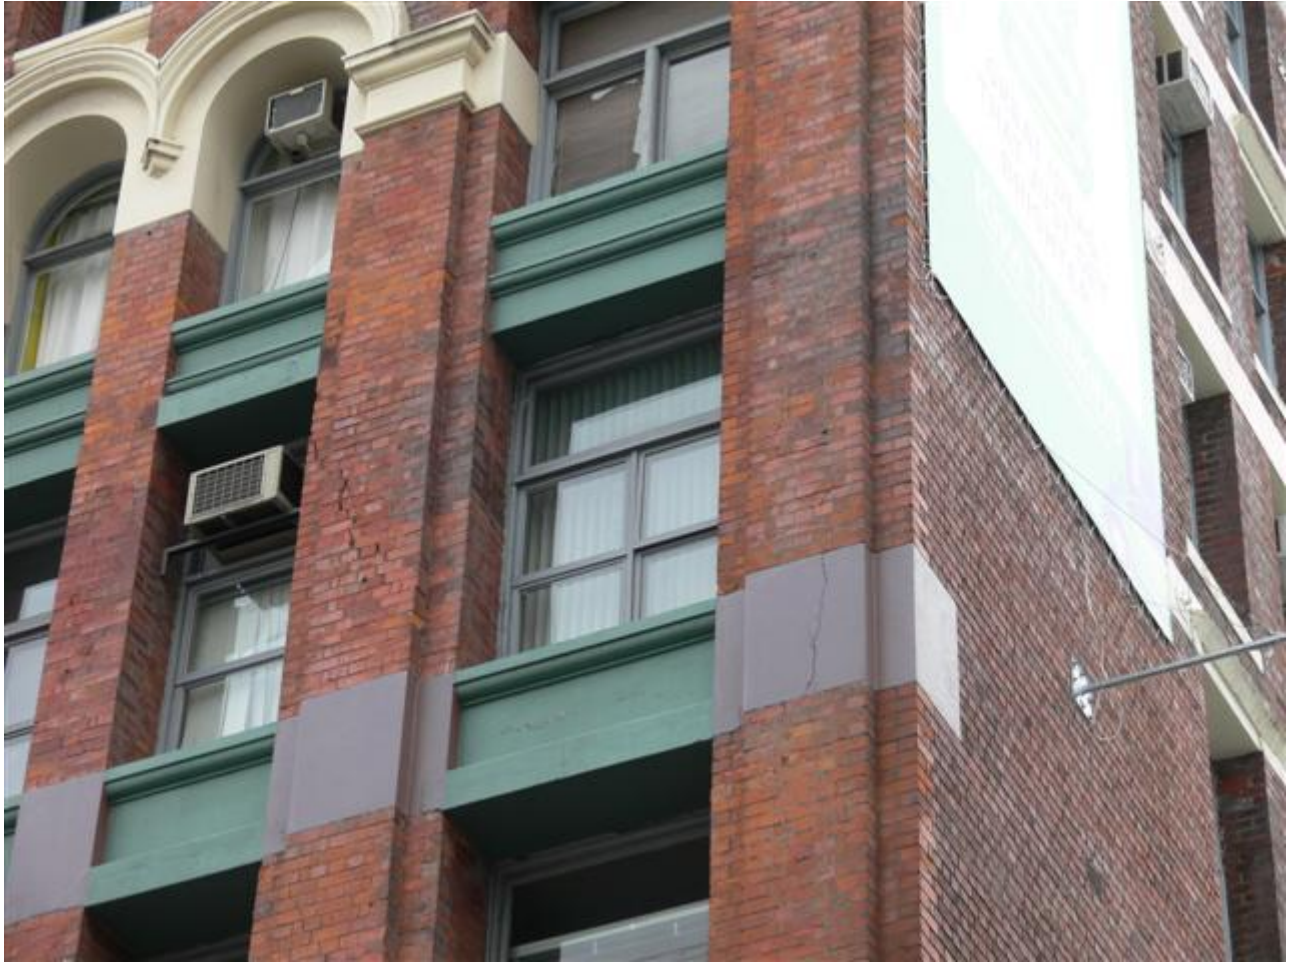
External inspection on September 10 (the day after the earthquake) indicated that most of the load bearing masonry piers had some form of visible damage, with the most clearly discernable damage photographed below.

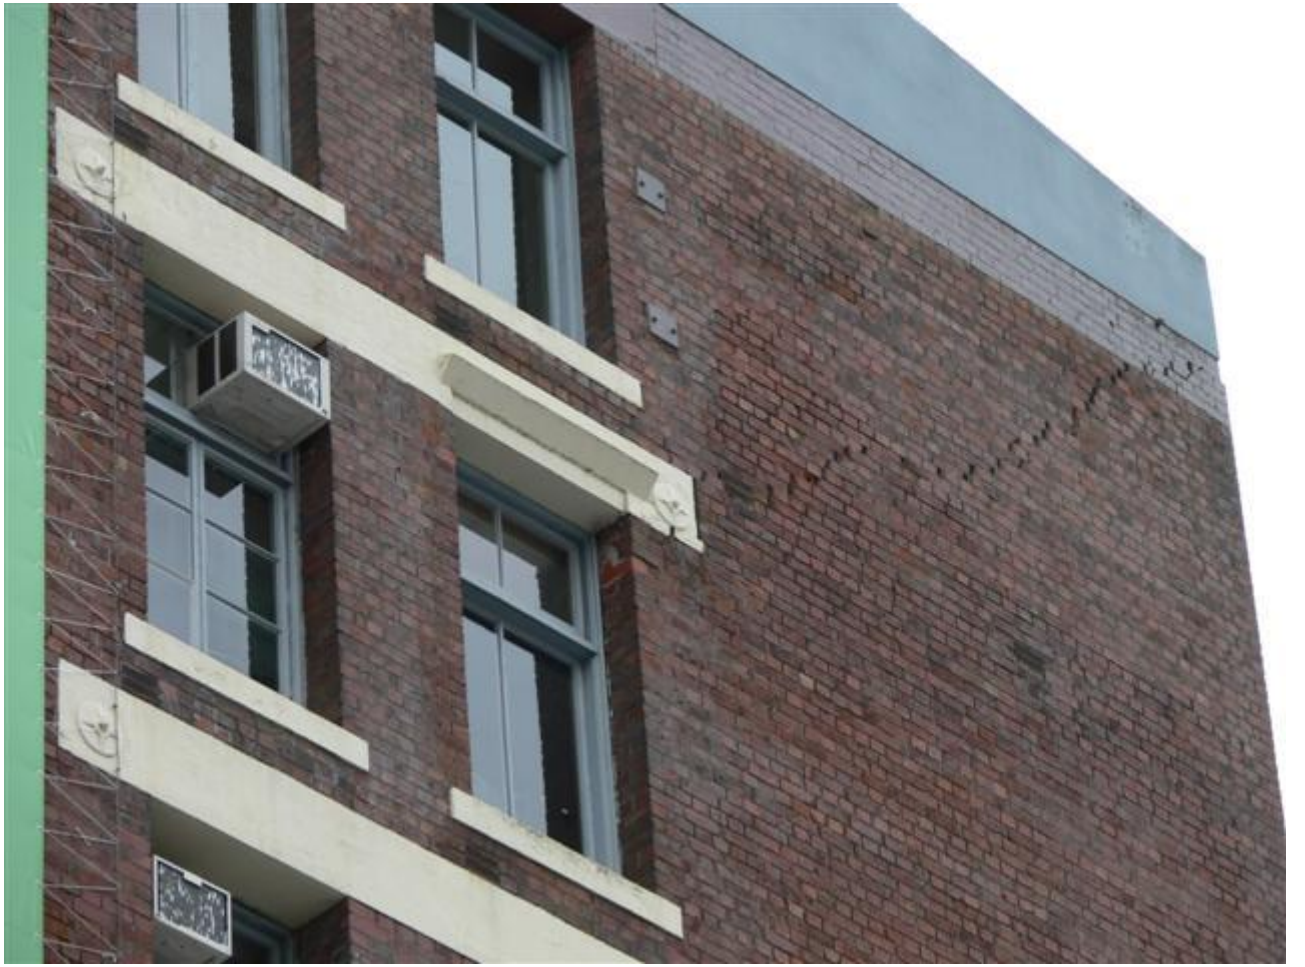
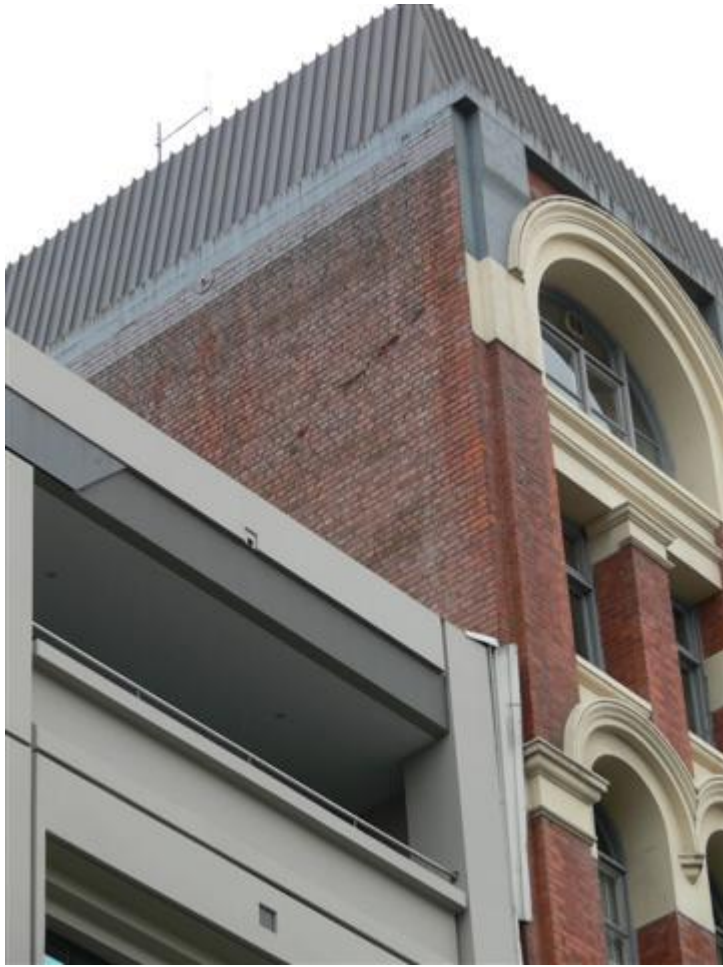
In addition, diagonal cracks at the top of the rear walls suggested that the building had been subjected to torsional deformations during the earthquake.

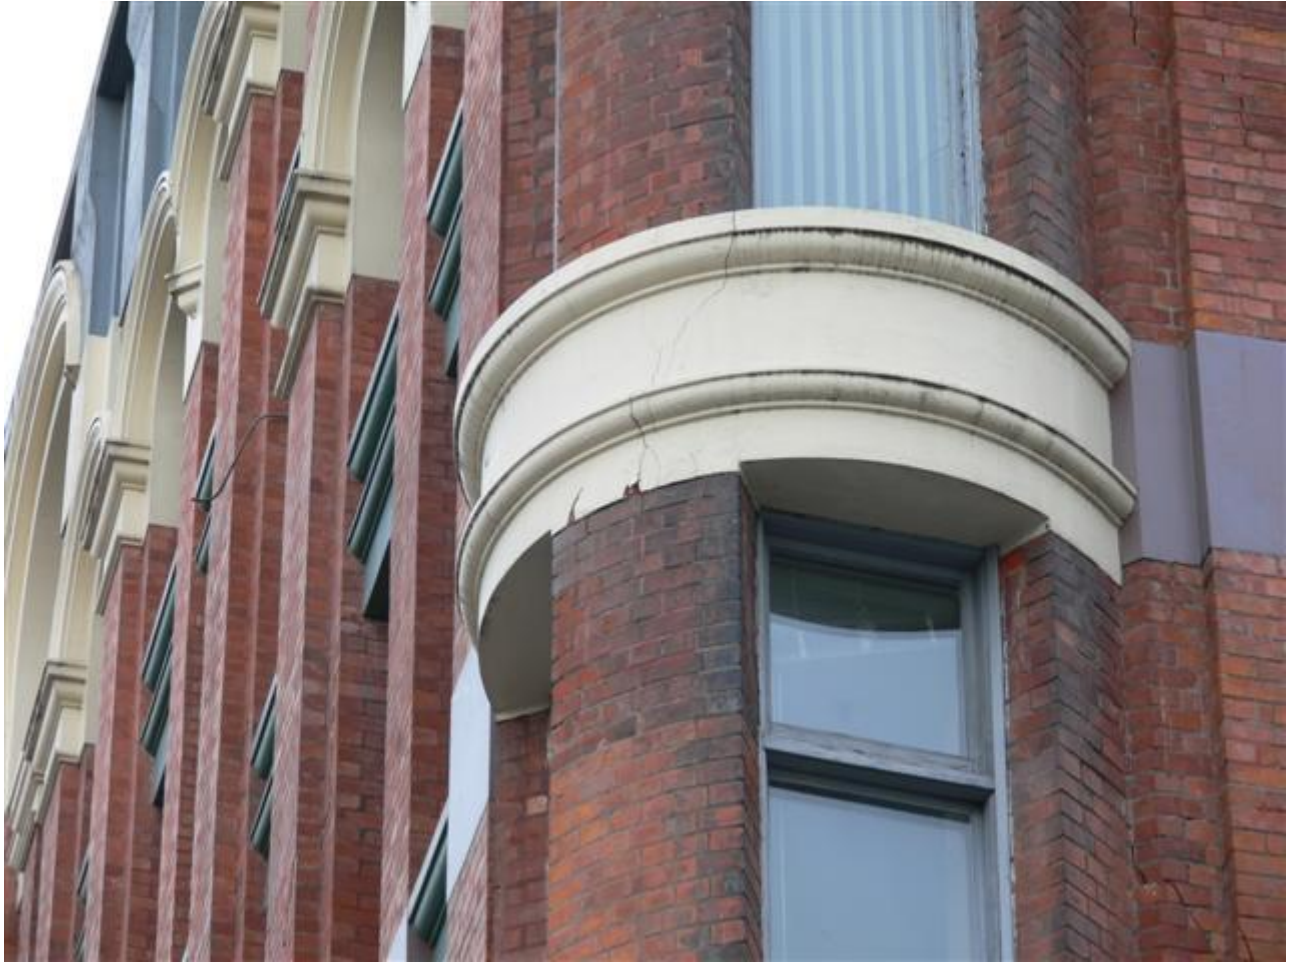
A particular concern was the safety of the corner tourelle, as open cracks could be traced at various locations up the full height of this ornamental protrusion, and it seemed plausible to imagine that the entire element could shear off from the main building structure.

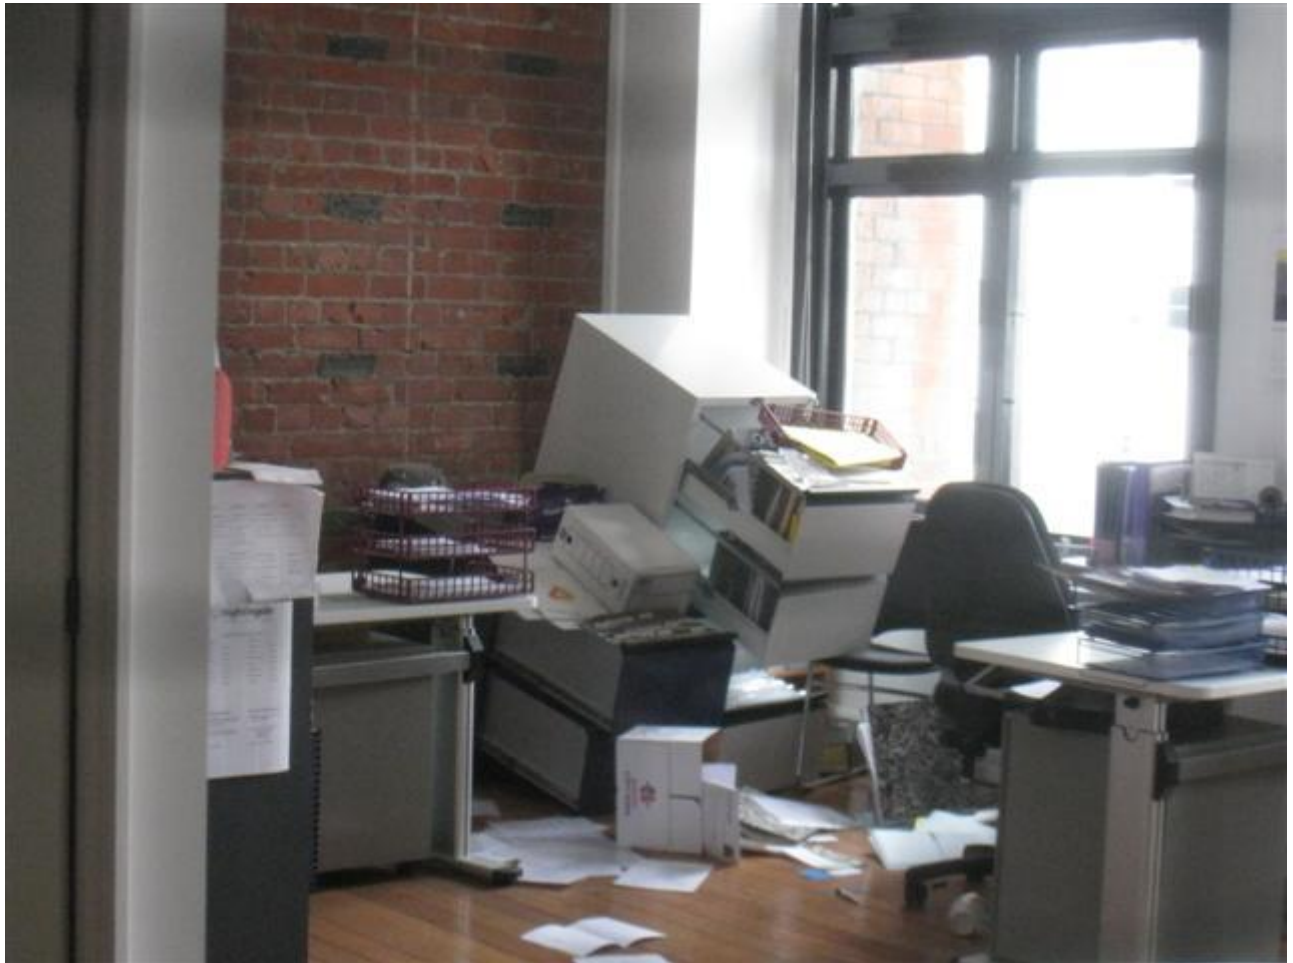
During the initial building inspection it was observed that building contents had been shaken about, as shown below.

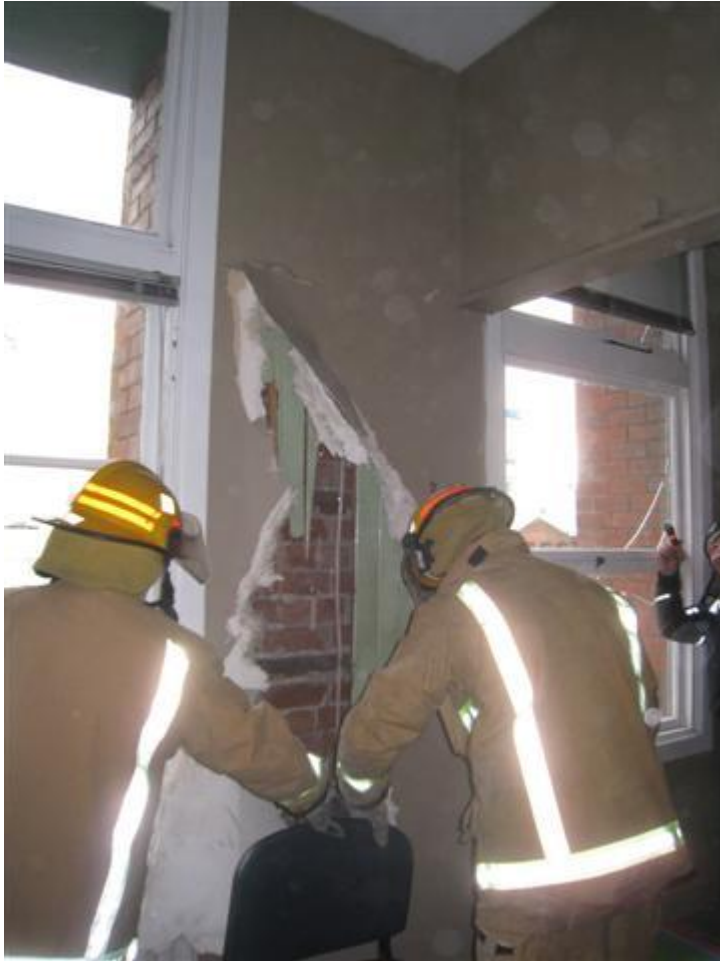
In order to establish the severity of the cracking that was observed on the exterior of the masonry piers, it was necessary to remove the claddings on the internal surfaces of the piers as shown below.

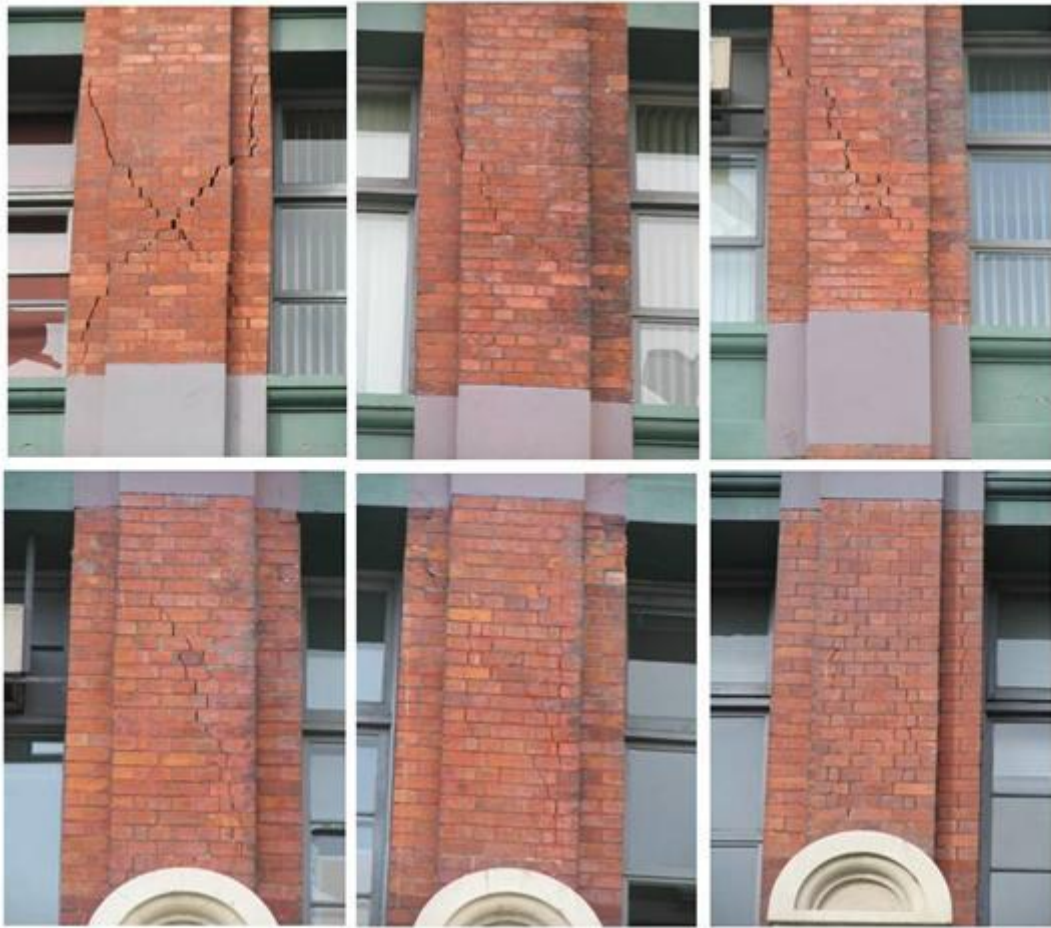
During the first inspection on September 10 the building received a rating of Y2, indicating that the building was dangerous to occupy and that repairs to the building were necessary before it could be returned to service, but that it was not expected to be necessary to demolish the building.

However, after repeated aftershocks the building was reclassified on September 12 as red, indicating that it was now expected that complete building collapse was plausible. A review of some of the damaged external masonry piers is shown below.
