EARTHQUAKE-DAMAGED UNREINFORCED MASONRY BUILDING TESTED IN-SITU

Figure 2. Allen's Trade Complex B-East building

Figure 3. B-East building damage due to 2007 Gisborne earthquake

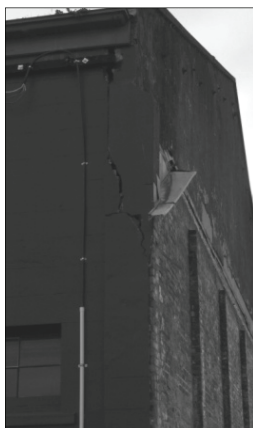
During the 2007 Gisborne earthquake the B-East building suffered extensive structural damage (shown in Figure 3) to the extent that significant post-earthquake repairs were necessary and the removal of two gable ended walls was required. As a result the building was designated unstable and unsafe to occupy until reconstruction took place. Following the 2007 Gisborne earthquake, numerous visible cracks in the vicinity of the window piers and wall corners were observed. As shown in (a) and (b) in the Figure 3 the top portion of the northern gable corner separated from the cross wall, causing the entire top portion of the southern gable to permanently deform outwards from the roof diaphragm. The northern gable sustained less damage, with only a small number of visible cracks. Due to instability and safety considerations, the top portion of the southern end gable required demolition prior to the commencement of any testing. There were a number of locations where the anchors connecting the top of the gable to the roof diaphragm were pulled out from masonry, as shown in Figure 3(c).

(a) Cracking of the top gable corners

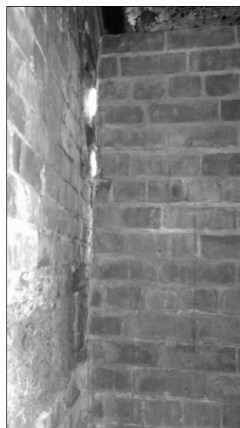
(b) Cracking of the top gable corners (internal view)

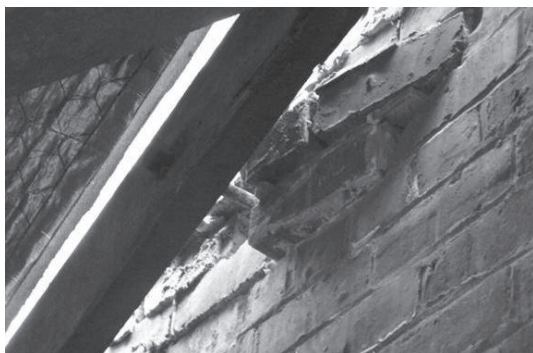
(c) Roof anchor pull-out

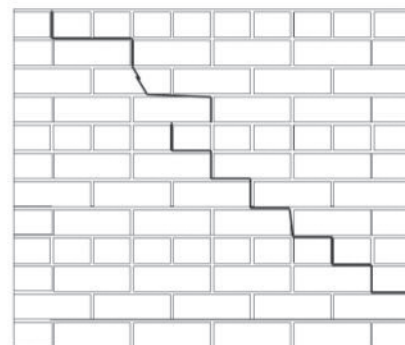
All wall panels failed by crack propagation through the mortar joints in a step-wise mode, with the final crack patterns illustrated in Figure 7. In order to provide direct comparison to the results obtained from laboratory-built wall panels, and to facilitate interpretation and use of the data by structural engineering practitioners, the wall panel displacements are reported as shear strain as shown in Figure 8. It is noted that test panel AGW4 (as-built Gisborne wall panel 4) suffered minor damage during the setup preparation in the laboratory, resulting in the sample being pre-cracked at the 7th brick course from the bottom. This is visible in the crack pattern shown in Figure 7(b) and is responsible for the reduction in shear stress at cracking that is illustrated in Figure 8(d).

the average shear stress at cracking was 0.057 MPa, with a maximum average shear stress of 0.082 MPa. The crack pattern observed at failure closely matched the pattern obtained in laboratory-built wall panels with weaker mortar mixes (Russell 2010). For all wall panels, with an exception of AGW3, the maximum shear stress was higher than the shear stress at cracking, which was not observed in laboratory-built samples where shear stress decreased immediately following cracking (Russell 2010). The results presented in Table 4 enable a comparison of the results from laboratory-built wall panels constructed using different mortar mixes to wall panels extracted from the B-East building. The results from wall panels manufactured in the laboratory with 1:2:9 mortar mix (cement:lime:sand) closely resemble values obtained from the B-East building wall panels. The average maximum shear stress for the laboratory-built wall panels using a 1:2:9 mortar mix was 0.094 MPa, which compares well to the 0.082 MPa mean value obtained from the B-East building wall panels. Laboratory built wall panels using a weaker mortar mix of 0:1:3 and a stronger mortar mix of 2:2:9 resulted in maximum shear stresses of 0.04 MPa and 0.50 MPa respectively, which were outside the range obtained from wall panels from the B-East building.

(a) Typical crack pattern

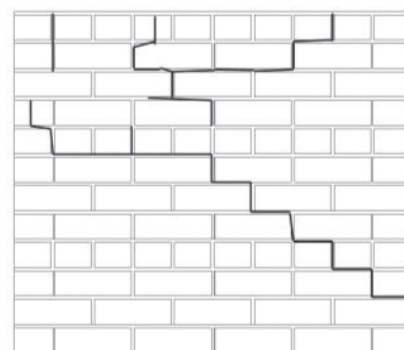
The diagonal shear strength varied among the tests, but within reasonable limits for URM construction. With the exclusion of the pre-damaged wall panel AGW4

(b) AGW 4

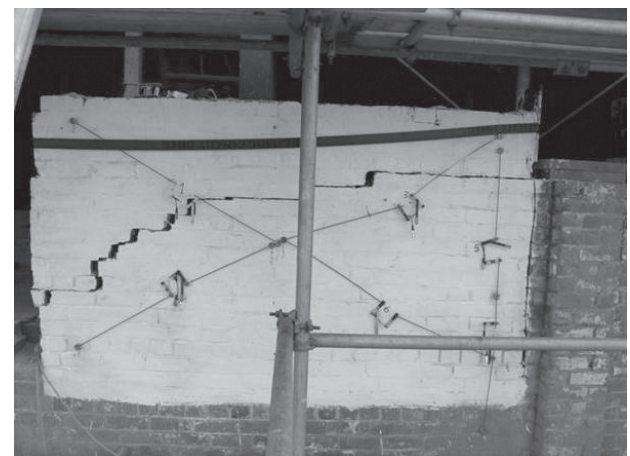
Initial cracking was observed at a displacement of approximately 2 mm (0.5% drift) with a corresponding base shear of 9.1 kN. With increasing loading the crack propagated from the loading side in a step-wise pattern through mortar joints and sliding of the section occurred, with the final crack pattern being as shown in Figure 11. The base shear-drift response is shown in Figure 12. Only the displacement values obtained from the top LVDT are reported here.

Figure 11. The crack pattern after push test

During the test it was observed that the crack initiated at the loaded edge of the wall and gradually propagated to the opposite edge, indicating that the cohesion was engaged with the increasing load levels as indicated by the changing gradient between 0 and 0.2% drift for the curve shown in Figure 12. Based on simple static analysis, the applied force and the normal force due to the self weight of the test section acting on the sliding plane resulted in the coefficient of friction μ for the wall section being calculated to be 0.7.

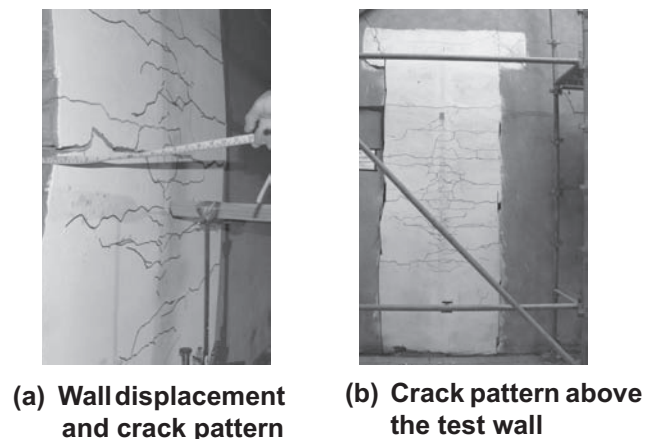
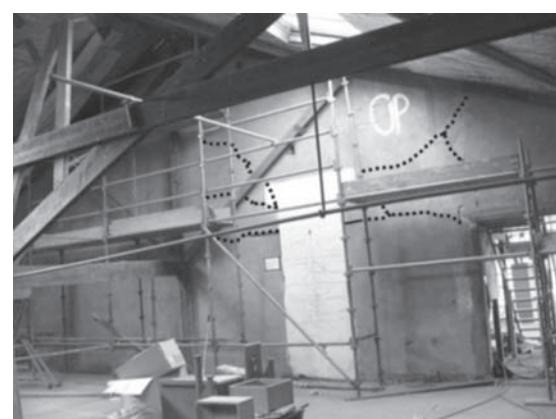
releasing the airbag pressures) so that crack locations could be observed and marked at different stages throughout the test. Numerous new cracks formed in the vicinity of the strip and the final crack pattern is illustrated in Figure 19. The pressure in the airbag was increased until a total mid-height displacement of 130 mm was reached. At this displacement substantial wide cracking of the masonry above the tested wall strip had occurred (shown in Figure 19 (c)) and due to safety considerations the pressure in the airbag was not further increased. The total lateral load – mid-height displacement response is shown in Figure 18.

Figure 19. NSM repair – final crack pattern

A single CFRP NSM strip was shown to increase the post-cracking wall strength, as illustrated in Figure 18, the wall strength increased by approximately 35%. Due to a large number of newly formed cracks it is clear that there was a larger amount of energy dissipation occurring compared to the as-built condition. Even though further research is required to accurately establish the design guidelines for this type of seismic retrofit, this and previous testing have illustrated that this retrofit technique provides a simple and cost effective alternative to seismically strengthen URM buildings and their components.
