# IN-FIELD SIMULATED SEISMIC TESTING OF AS-BUILT AND RETROFITTED UNREINFORCED MASONRY PARTITION WALLS OF THE WILLIAM WEIR HOUSE IN WELLINGTON

By: Hossein DERAKHSHAN<sup>1</sup>, Dmytro DIZHUR<sup>2</sup>,  
Ronald LUMANTARNA<sup>3</sup>, John CUTHBERT<sup>4</sup>,  
Michael C. GRIFFITH<sup>5</sup> and Jason M. INGHAM<sup>6</sup>

**Figure 2. WW wing building plan - level 3 (provided by Dunning Thornton Consultants Ltd)**

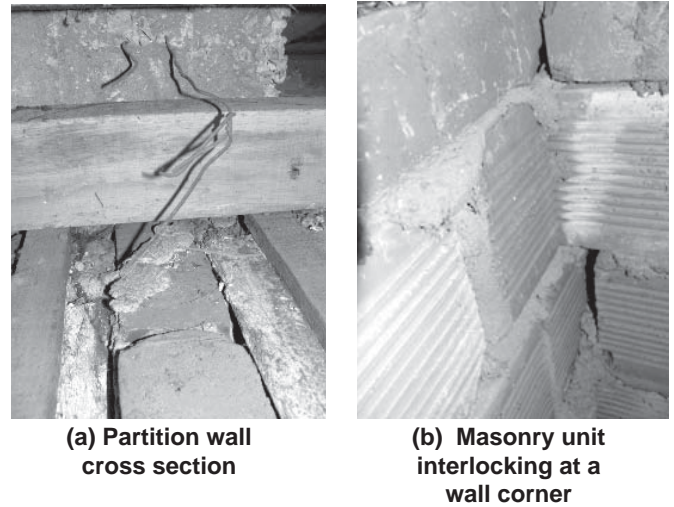
**Figure 5. Photos taken during building roof inspection**

Top-storey walls had a top support condition different from the second level walls. This was investigated by accessing the building roof, and it was found that the wall top was not directly connected to the roof timber structure (Figure 4b). Little or no stiffness was presumed to be provided by the skirting connecting the wall to the ceiling constructed from gypsum plaster boards. During roof inspection on top of wall C8-C9, evidence was found of steel wires (Figure 5a) inserted into the concrete column to secure the masonry wall. The masonry corners lacked full inter-connection in all courses, but a few of the visible top courses (approx. 50%) were interlocked (Figure 5b).

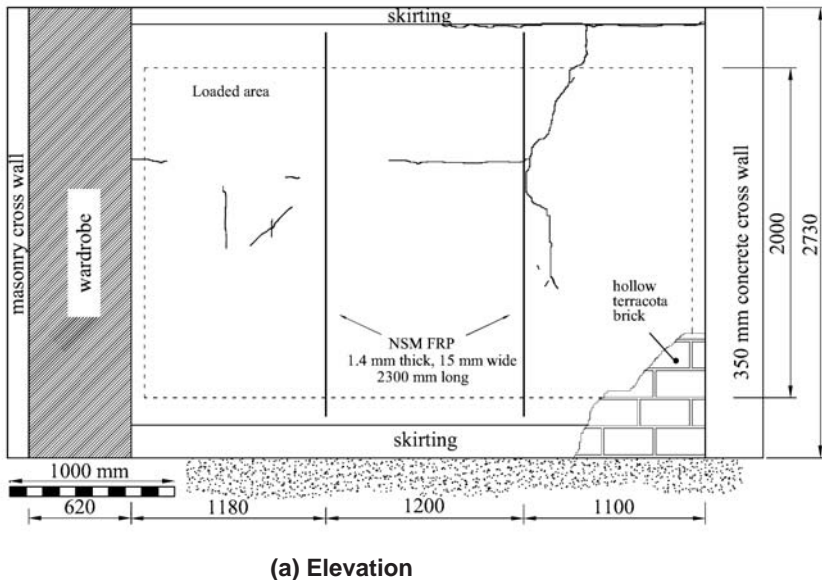
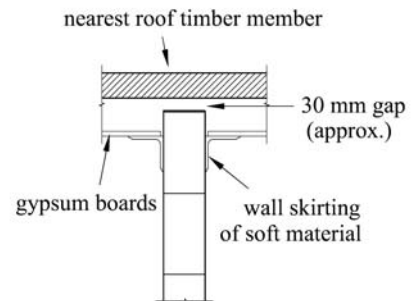
**Figure 4. Wall C16-C17**

Partition walls B3-B4 and B17-B18 had similar boundary conditions, with both walls connected to reinforced concrete elements at one end and to a masonry return wall at the other end and to concrete floors below and above the wall. Similarly, wall C8-C9 was connected (Figure 3) to a reinforced concrete column at one end, to a masonry return wall (2200 mm long) at the other end, and was constructed on a reinforced concrete floor. Wall C16-C17 had similar boundary conditions to C8-C9, except that the reinforced concrete column was replaced by a reinforced concrete shear wall and a timber wardrobe that contributed to the wall end support as shown in Figure 4.

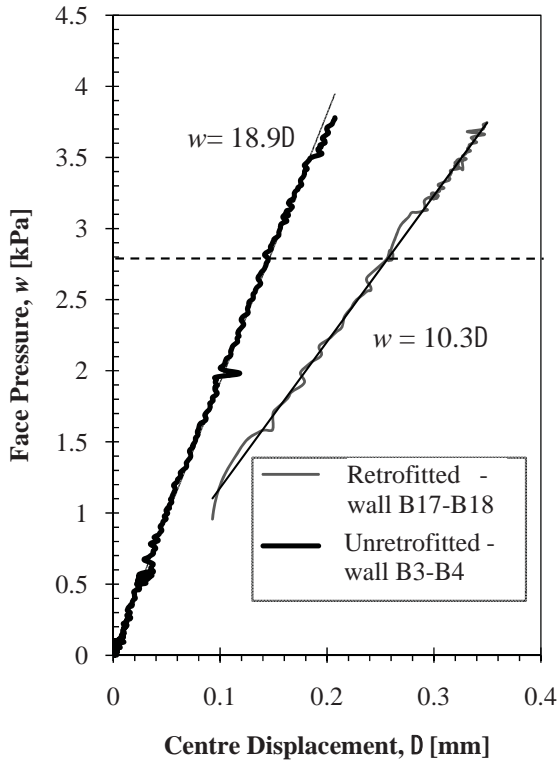
Figure 11. Response of as-built and retrofitted walls in stage 1

Figure 11 shows a comparison between the force-displacement plots of wall B3-B4 (as-built, AB1) and wall B17-B18 (retrofitted, AB2). Surprisingly, the flexural stiffness of the retrofitted wall was less than that of the as-built wall. Because of identical dimensions for wall B3-B4 and B17-B18, the difference in flexural stiffness of the walls was attributed to the possible variation in material properties and difference in quality of construction between the walls. Consequently, the flexural stiffness varies from wall to wall within the building.

Figure 11 shows that both walls satisfied the current seismic demand (NZS 1170.5:2004), estimated to be approximately 2.8 kPa.

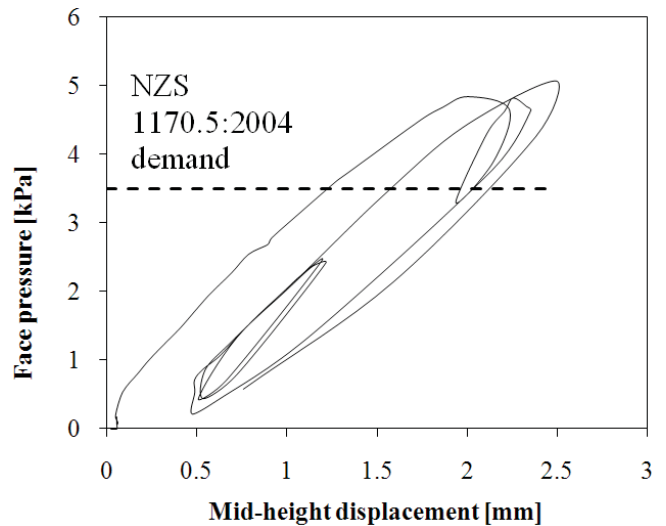
Figure 13. Test AB3, wall C8-C9

In stage 2 testing, test AB3 was conducted by applying load in 2 half-cycles, but a typical loading history as represented by Figure 12 was applied in test AB4 and AB5. The first test, AB3, was conducted on wall C8-C9 in the as-built condition. Figure 13 shows the equivalent wall face pressure versus the wall mid-height displacement. The wall face pressure was calculated as the total measured lateral force sensed by the load cells divided by the wall total area. As mentioned previously, a crack pattern appeared to have existed on the top-storey partition walls before commencement of the tests. Although monitoring the crack propagation was difficult due to a layer of paint on the wall, subsequent crack pattern observations confirmed that the wall damage remained limited to the existing cracks being opened. At an equivalent wall face pressure of approximately 1.4 kPa, a few vertical cracks were visible closer to the top (unrestrained) edge of the wall, and thereafter the crack pattern and extent of crack widths remained constant. The wall face pressure exceeded the current seismic load demand as shown in Figure 13, and the wall capacity up to 149% of the calculated demand (5.2 kPa vs. 3.5 kPa) was confirmed.

Both walls underwent small amounts of plastic deformation (approx. 0.5 mm), and both walls satisfied the current seismic demand (NZS 1170.5:2004) as depicted in Figures 13 and 14.

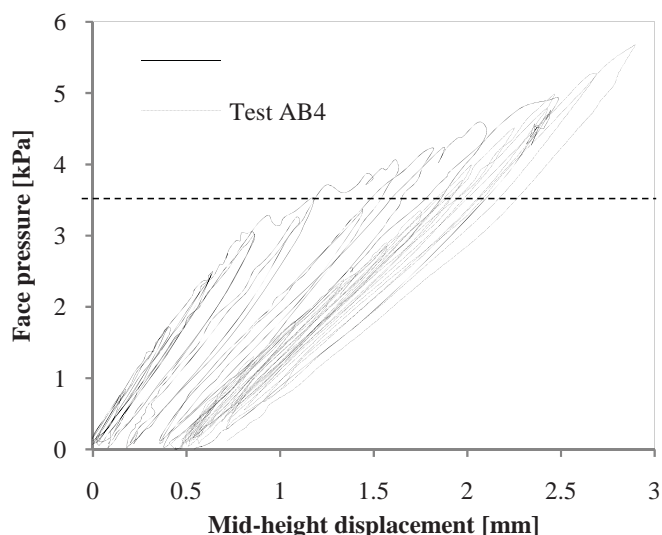
Figure 14. Test AB4 and AB5, wall C16-C17

The lateral out-of-plane response of wall C16-C17 is shown in Figure 14 for the performed as-built and retrofitted tests. Analysis of the response envelope in Figure 14 showed that at a face pressure of approximately 3.2 kPa the wall stiffness reduced by approximately 65% from 3.6 kPa/mm to 1.2 kPa/mm.

Wall C16-C17 was retrofitted using a similar techniques to that described in previous section and it was re-tested. The results of the retrofitted wall test are shown in Figure 14. It can be seen that the flexural stiffness of the partition wall increased following the retrofit from 1.2 kPa/mm to approximately 1.8 kPa/mm.
