LABORATORY TESTING OF UNREINFORCED MASONRY WALLS RETROFITTED WITH GLASS FRP SHEETS

H. MAHMOOD, A. P. RUSSELL, J. M. INGHAM

Department of Civil & Environmental Engineering
The University of Auckland
Auckland, New Zealand

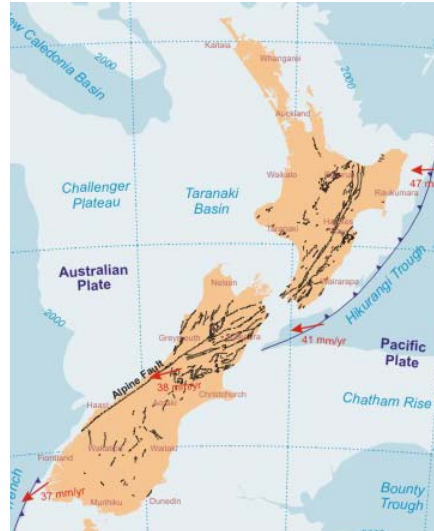
Figure 1. The geological setting of New Zealand (Reproduced with permission of GNS)

New Zealand is one of the most active seismic places on the earth (Natureandco.com). It lies at the edge of the Australian and Pacific plates (Figure 1). Past earthquakes in the region have caused major losses. The most significant of these earthquakes was the 1931 Hawke's Bay Earthquake that resulted in the death of 256 people and caused widespread damage in the Hawke's Bay region (Dowrick 1998). Most of the dwellings in the area were URM. The popularity of URM in New Zealand decreased after that earthquake and it was banned altogether in 1965. However, the current New Zealand building stock consists of a significant number of URM structures. Many of these buildings form a part of New Zealand's architectural heritage. Unfortunately, these structures also constitute seismic hazard to New Zealand's citizens. The current New Zealand Building Act 2004 (The Department of Building and Housing 2004) requires such structures to be either demolished or upgraded to ensure their safety under moderate earthquakes.

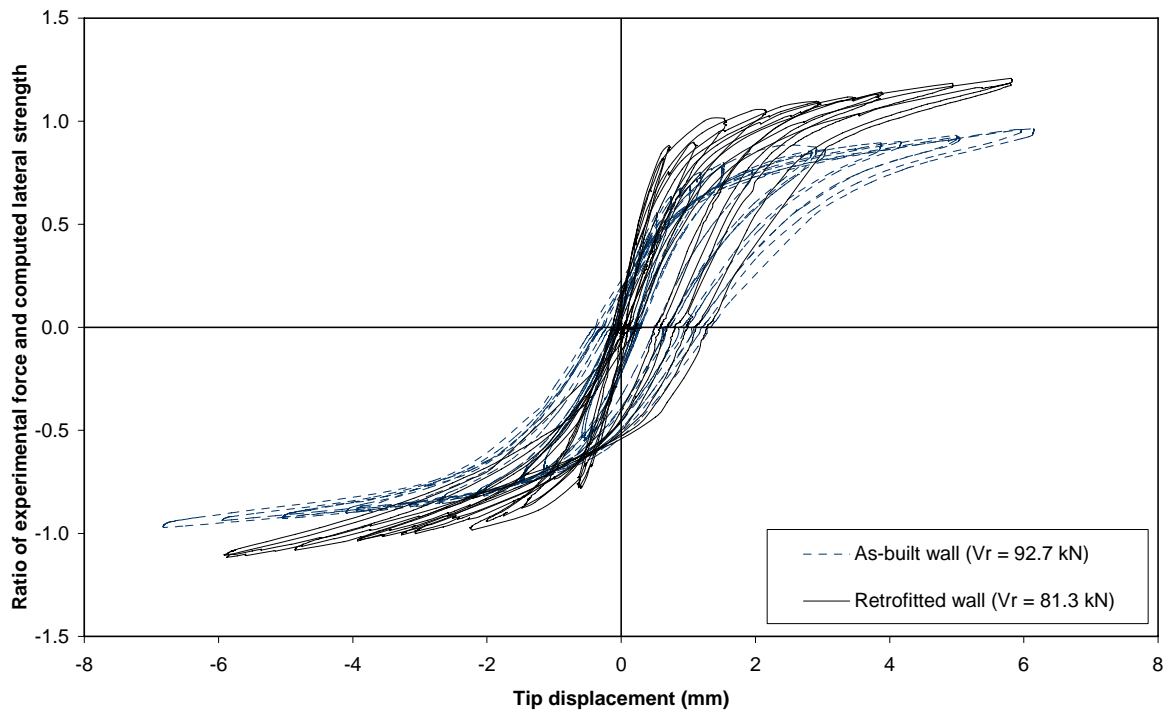
Fig. 6 shows a comparison of the hysteresis plots for the both walls. The ratio of the lateral force and computed lateral strength for each wall is plotted along the y-axis. Wall tip displacement is plotted along the x-axis.

Some preliminary observations have been made by comparing the hysteresis behaviour of both walls. First, the slope of the retrofitted wall is much steeper indicating a higher stiffness than for the as-built wall. This can be attributed to the presence of vertical fibres holding the main glass fibres. Second, the initial strength of the retrofitted wall is about 25% greater than the as-built wall. The difference in strength between two walls is constant until the end of the displacement cycles. Reasons for this are still being investigated. Third, a strain-hardening type behaviour is observed following the initial displacement level of 0.5 mm. This is due to increase of the post-tensioning forces as the walls rocked.

Figure 6. Ratio of the experimental force and computed lateral strength versus tip displacement
