Test Report

“Airbag Testing of a One-way Out-of-plane Unreinforced Masonry (URM) Wall”

Airbag Testing of a One-way Out-of-plane Unreinforced Masonry (URM) Wall

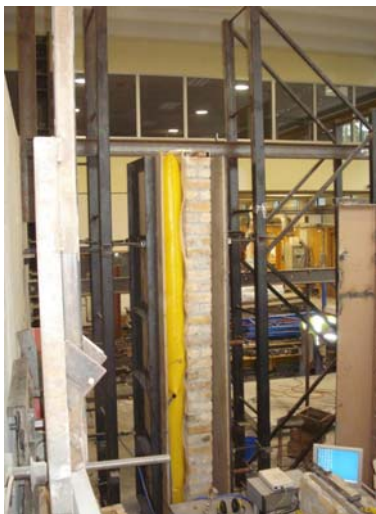
Figure 1: (a) Test Setup

A setup shown in Figure 1(a) was used to apply uniform pressure on the surface of a URM wall acting in one-way condition. The wall, with a height, width, and thickness of 3500 mm, 1200 mm, and 220 mm, respectively, was restricted at top and bottom for movements perpendicular to its plane. For this purpose, steel angle sections with a length equal to the length of the wall were used on both sides of the panel at the ground and top elevations. Although it was expected that the wall would crack from the mortar joint immediately above or below these support levels, the assemblage of the steel sections proved to allow for rotation of the wall at the support levels. Zero axial load was assumed throughout the testing.

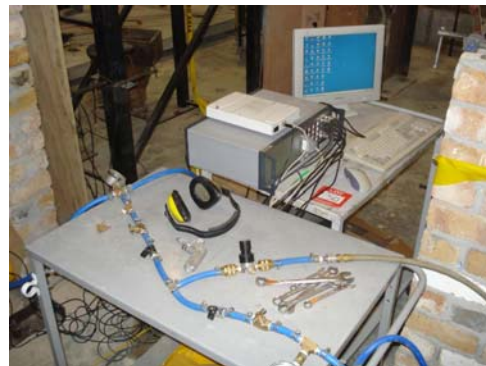
(b) Data Acquisition System and Pneumatic Unit

Two Bigfoot vinyl airbags with a thickness of 0.25 mm were used to generate the loads. The air used to inflate the airbags was supplied from the main compressed air supply at the Test Hall. A manually operated pressure control system shown in Figure 1(b) was used to reduce the air pressure from 8 PSI to the applicable pressure range, starting from zero and increasing up to about 1.15 kPa. By selecting the same type and length of hoses and connections for each airbag, it was ensured that both of the airbags were inflated up to a same pressure level. It is noteworthy that at the beginning, a total of four airbags have been arranged in a system to apply cyclic loads to the specimen. During the half cycle testing an observation was made, which prevented the cyclic test to be initiated. The problem was the slow deflation of the airbags in the opposite side, when the wall was being tested from one side (refer to Observation of the Test). It was then concluded that the setup needed to be improved in future to allow for cyclic testing being performed.

A National Instrument data acquisition (DAQ) system with 24 channels (Figure 1(b)) was used to accommodate for 8 cables from the load cells and one cable from the LVDT. Because of the severity of the electromagnetic noises being recorded by the NIDAQ machine, it was decided to record the test data with a frequency of 50 Hz. A post-processing code was then prepared to apply a low-pass filter to the records resulting in removal of data with frequency of more than 4 Hz.

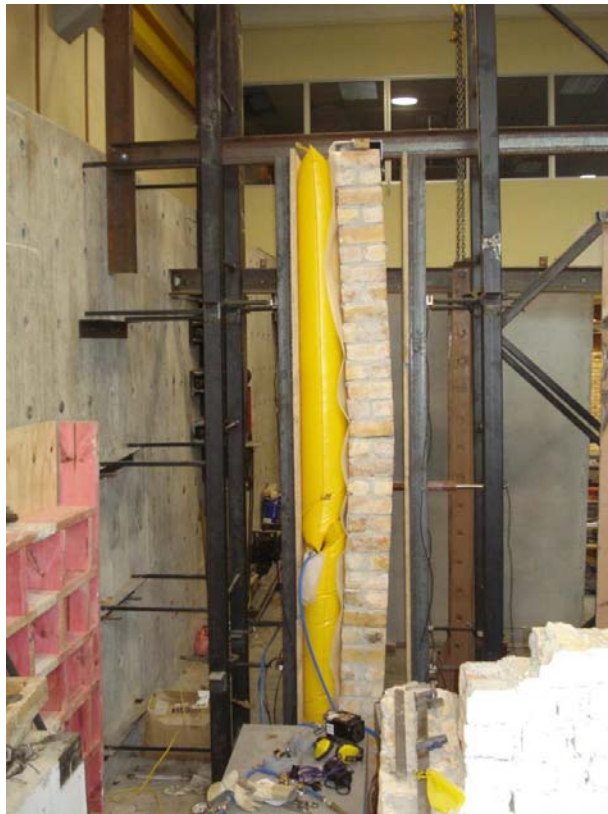
Figure 2: A single horizontal crack began to develop 350 mm above the wall mid-height; the supports at top and bottom of the wall allow for rotation of the wall, and therefore no crack was formed at the support levels. Four load cells connecting the backing frame to reaction frame at each side, and the single LVDT arrangement can be observed in the figure.

The testing was started with applying load from one side (Figure 2). The airbags pressure was slowly and uniformly increased from zero to the maximum value (about 1.15 kPa, point A in Figure 4, 5, and 6). At about the maximum load, a crack was started to be opened in a fashion suggesting that either it had already existed before or it was initiated without too much energy being released at once. At about the same instance of time as when the crack appeared, the pressure inside the airbags automatically started to decrease as the wall was deforming and the displacements were significant. The displacement of the wall at the crack was allowed to reach about 135 mm (0.61t), at which point the cracked wall looked nearly unstable (Figure 3). The supplying air hose was then stopped, and the airbags pressure was reduced by opening the release valves. As the pressure started to decrease, the weight of the wall acted as a stabilizing force, returning the wall to its first situation. The crack was no longer visible, when closed. No other damage than the above mid-height crack was observed in the wall specimen. The testing duration was approximately 15 minutes.

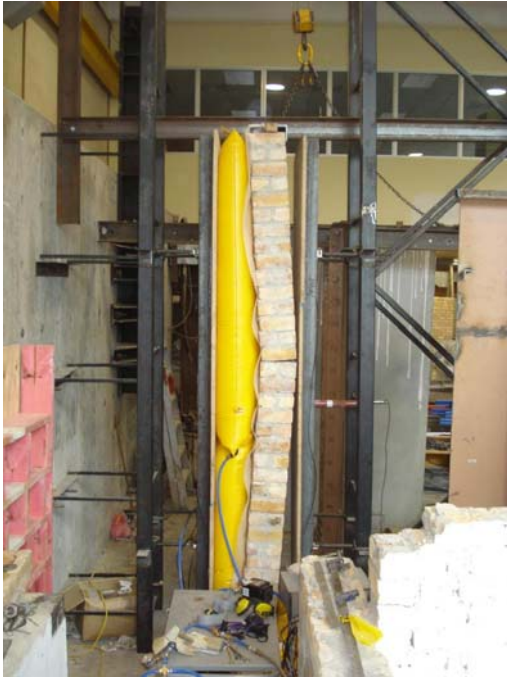
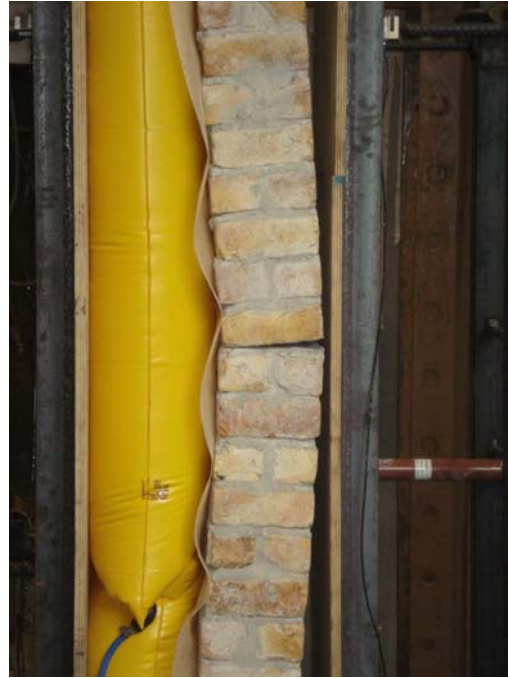
Figure 3: (a) wall at maximum displacement position (135 mm at the crack level); after this point the inlet air was stopped, and the airbags connections were opened to allow for airbag deflation. The wall stabilized to its resting position by its own weight. (b) mid-height crack
