LABORATORY TESTING OF UNREINFORCED MASONRY WALLS RETROFITTED WITH GLASS FRP SHEETS

H. MAHMOOD, A. P. RUSSELL, J. M. INGHAM

Department of Civil & Environmental Engineering
The University of Auckland
Auckland, New Zealand

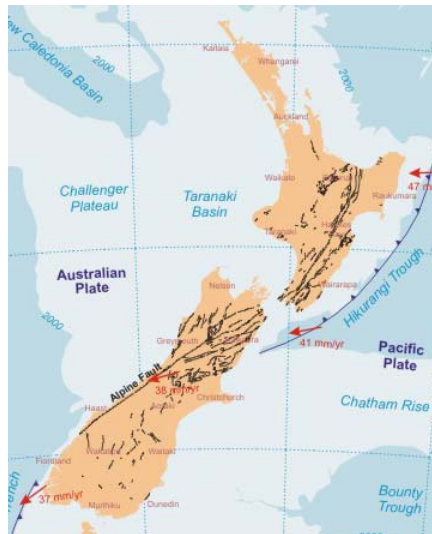
Figure 1. The geological setting of New Zealand (Reproduced with permission of GNS)

New Zealand is one of the most active seismic places on the earth (Natureandco.com). It lies at the edge of the Australian and Pacific plates (Figure 1). Past earthquakes in the region have caused major losses. The most significant of these earthquakes was the 1931 Hawke's Bay Earthquake that resulted in the death of 256 people and caused widespread damage in the Hawke's Bay region (Dowrick 1998). Most of the dwellings in the area were URM. The popularity of URM in New Zealand decreased after that earthquake and it was banned altogether in 1965. However, the current New Zealand building stock consists of a significant number of URM structures. Many of these buildings form a part of New Zealand's architectural heritage. Unfortunately, these structures also constitute seismic hazard to New Zealand's citizens. The current New Zealand Building Act 2004 (The Department of Building and Housing 2004) requires such structures to be either demolished or upgraded to ensure their safety under moderate earthquakes.

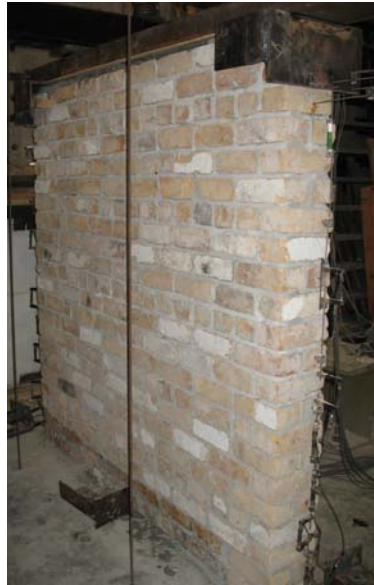
Figure 2. As-built wall

The test walls were built by a professional bricklayer using recycled bricks. The bricks were obtained from demolished buildings and cleaned for use in the tests. A weak mortar mix, ASTM type 'O' (1:2:9 cement/lime/sand by volume) was selected to simulate decayed mortar in old URM structures. Each test wall measured 1970 mm long \times 1970 mm tall \times 240 mm thick. The walls were built two leaves thick in the common bond pattern, with header courses every fourth course. The walls were built on the laboratory strong floor. They were bonded to the floor using a strong cement/sand mortar mix. It was intentionally decided to build the walls in a way that replicated the observed, often deteriorated, finish quality of walls in real buildings.

One wall was left as-built for comparison of the test results and behaviour with the retrofitted wall. Figure 2 shows the as-built test wall. The other wall was retrofitted using uni-directional glass FRP (GFRP) sheets. The manufacturer-provided typical properties of the sheet are given in Table 1. The decision to use GFRP was taken on the basis of cost and oft-reported lack of additional strength gain with the more expensive alternative, carbon FRP (CFRP) (e.g. Albert et al. 1998). The wall was retrofitted on one face only. This is consistent with FRP retrofit practice. FRP is generally applied only on the inside face of URM walls in a building in order to preserve the architectural façade. The test wall was strengthened in shear only to allow the wall to fail in a flexural mode, which is a ductile/pseudo-ductile mode of failure. Due to time constraints, the retrofit was applied before the as-built test had proceeded. Two layers of GFRP sheet were applied for the retrofit. The glass fibres were oriented horizontally for both sheets. Figure 3 shows the fibre layout and the retrofitted wall.

As-built Wall: The as-built wall deformed by rocking. Initial cracking was observed at a displacement of 2 mm. The first crack appeared at the right edge of the wall, three courses above the wall base. The corresponding lateral force was 74 kN. With increasing displacements, the crack propagated towards the other edge of the wall. Another crack appeared on the left side of the wall at 5 mm push displacement. At larger displacements, both cracks joined and the wall started to rock at 3-4 courses above its base. This test was continued beyond 6 mm displacement. However, results only up to 6 mm displacement are reported here. An increase in lateral force was observed after initial cracking

where α = factor equal to 0.5 for fixed-free cantilevers; P = total gravity load on the cracked section = 184 kN for this wall; L = length of the wall = 1970 mm; and h_{eff} = height to the resultant of lateral force = 1760 mm, smaller than the total wall height due to failure three courses above the wall base. Using the above values, the rocking capacity of the wall is computed equal to $V_r = 92.70$ kN. The actual strength of the wall, 74 kN, was about 20% lower than the computed lateral strength.

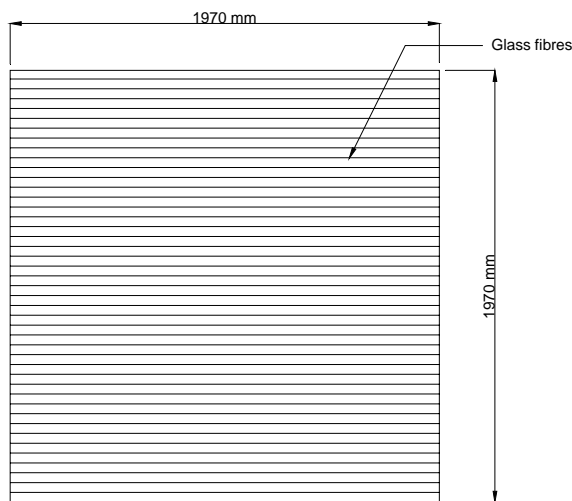
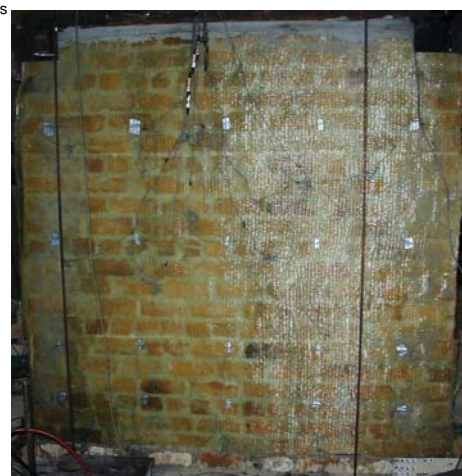
Figure 3. FRP configuration

The GFRP sheets were applied using a multi-stage process. First, the wall surface was ground level by an angle grinder. After grinding, the imperfections in the wall surface were filled with putty to obtain a near smooth surface. The primer epoxy coat was then applied to the wall using paint rollers. Separately, a GFRP sheet was saturated with epoxy. The saturated sheet was positioned on the wall by hand and worked against the wall by paint rollers to achieve a good bond. The sheet was anchored at its ends to the wall by fibreglass anchors to avoid premature peeling failures. The second sheet was bonded to the first sheet using epoxy. The FRP sheets were left to dry for a period of two weeks. During this period, heating lamps were used to accelerate the curing process.

(a) schematic FRP layout

(b) FRP-retrofitted wall

Retrofitted Wall: The retrofitted wall also deformed by rocking. However, unlike the as-built wall, rocking occurred at the wall base. This was attributed to the presence of FRP sheet which held together the upper masonry courses. The initial crack appeared in a pull cycle at a displacement of 2 mm. The corresponding lateral force was 79.5 kN. The first crack on the left edge of the wall was observed at a push displacement of 4 mm. Both cracks joined at the base of the wall at a displacement of 5 mm. The test was stopped at a displacement of 6 mm when the wall visibly started to rock at its base.

Lateral strength of the wall can be computed per FEMA 356 using the following parameters: $\alpha = 0.5$; $P = 187$ kN; $L = 1970$ mm; and $h_{eff} = 2040$ mm. The rocking strength, V_r , of the wall is computed equal to 81.3 kN. The experimental and computed values of the lateral strength compare well for the retrofitted wall.

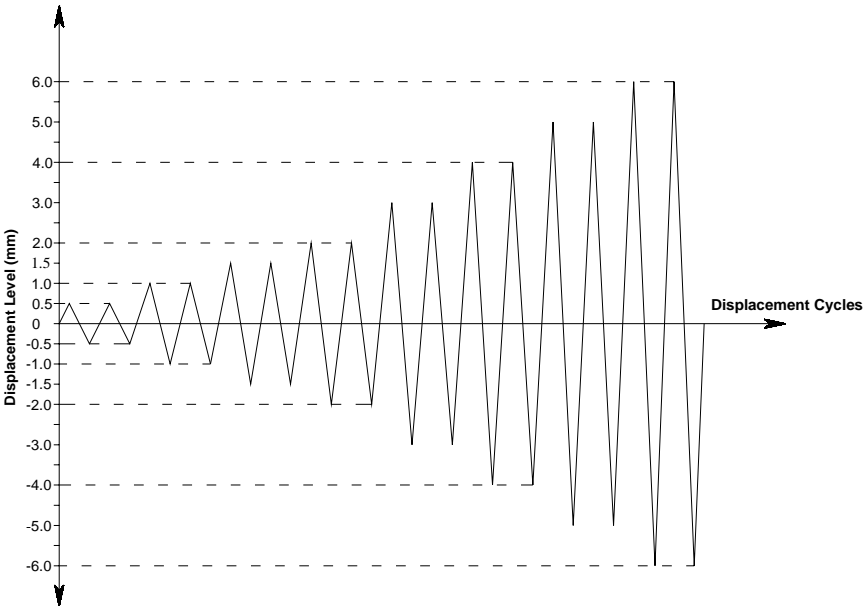
Figure 5. Displacement cycles

After the application of axial load, the lateral cycles were commenced. All loading cycles were displacement-controlled, with two cycles at each displacement level to obtain a stabilised crack pattern. This also verified the lateral force values at each displacement level. A test wall was initially pushed to 0.5 mm. The test was paused at this displacement level to inspect the wall and FRP sheet for any damage/debonding. The displacement was then released to bring the wall back to the original position. After this, the wall was pulled to 0.5 mm and the procedure was repeated. The displacement increment was maintained at 0.5 mm up to a displacement of 2 mm. For displacements greater than 2 mm, the increment was increased to 1 mm. The complete displacement cycle is shown in Figure 5. The test was stopped after a definite failure mode was established.
