# PSEUDO-STATIC IN-PLANE TESTING OF TYPICAL NEW ZEALAND UNREINFORCED MASONRY WALLS

## **ABSTRACT:**

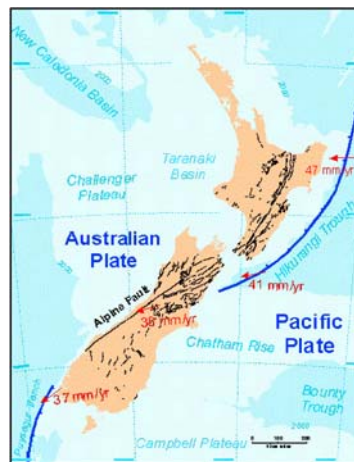
Figure 1: The plate boundary in New Zealand (reproduced from (Institute of Geological and Nuclear Sciences 2005) with permission)

New Zealand is located in a seismically active region and lies on the boundary of the Australian and Pacific tectonic plates. To the east of the North Island the Pacific plate is forced under the Australian plate. Under the South Island the two plates push past each other sideways, and to the south of New Zealand the Australian plate is forced under the Pacific plate (Figure 1).

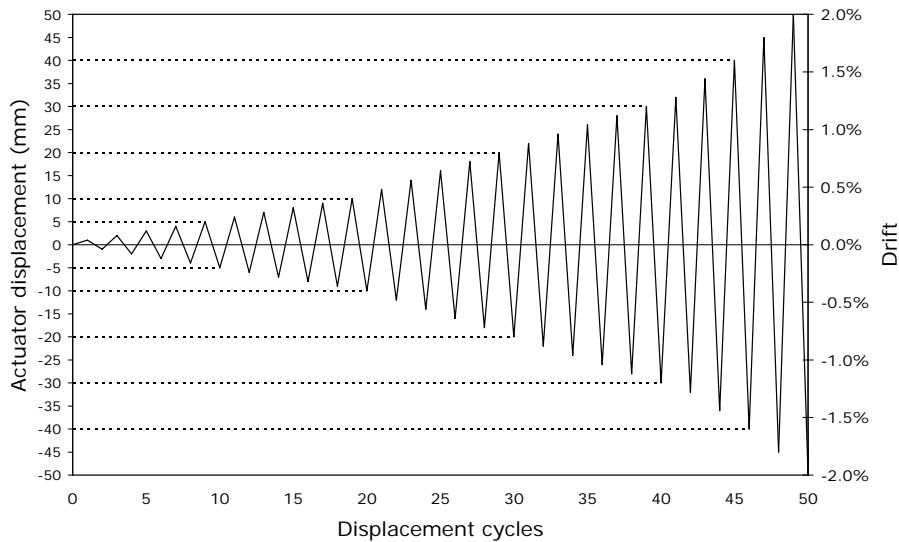
The loading history is shown in Figure 5. This displacement-controlled pseudo-static procedure was employed to capture the non-uniformly accumulated damage in the wall, and to enable observations of damage and failure mechanisms. The wall was subjected to displacements of 1 mm (0.04 % drift) in each direction and then the displacements were increased by increments of 1 mm each cycle until 10 mm was reached. Cracking was initially observed at 3 mm displacement. From displacements of 10 mm – 32 mm the increments were 2 mm (0.08 % drift) each cycle, and from 32 mm – 40 mm the increments were 4 mm (0.16% drift). From 40 mm – 50 mm the increments were 5 mm (0.2 % drift) each cycle, and the test was terminated at 50 mm wall tip displacement, corresponding to a wall tip drift of 2.0 %.

Figure 5: Pseudo-static displacement-controlled loading history employed in Wall A1

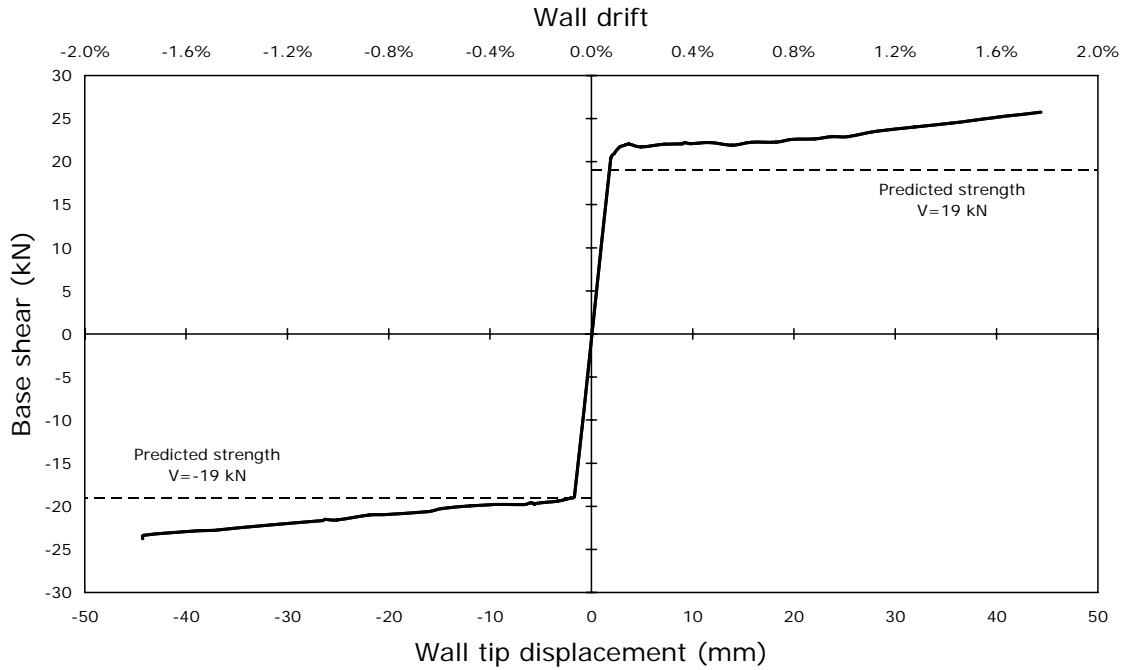
The wall behaved elastically to a drift of approximately 0.12 %, after which rocking ensued and a small increase in load was observed for the corresponding increase in displacement. The force-displacement envelope is shown in Figure 7 (the full hysteresis loops are not shown, due to an error in the laboratory data-logging equipment). It is thought that the increase in load after lift-off of the wall can be attributed to an increased force in the post-tensioning tendons as they elongated, which were used on the outside of the wall to provide the axial load. There was very little observed damage apart from the crack where the wall was lifting off, and some very small cracks in the compression region.

Figure 7: Force-displacement envelope

It has been reported by other researchers (Abrams 1999) that a wall drift of 1.0% corresponds to exceeding the limit state of collapse prevention (CP). FEMA 356 (2000) gives performance levels for primary URM structures of immediate occupancy (0.1 %), life safety (0.3 %) and collapse prevention (0.4 %); and for secondary structures, life safety (0.6 %) and collapse prevention (0.8 %). There was no collapse of this wall even when the test was terminated at a drift of 2.0 %.
