TESTING AND SEISMIC RETROFIT OF 1917 WINTEC F BLOCK URM BUILDING IN HAMILTON

By: Yi-Wei Lin¹, hossein DeRakhshan¹, Dmytro Dizhur¹, Ronald LUManTaRna¹, Liam WoTheRspoon² and Jason M. inGhaM³

Wintec F block is a two storey unreinforced masonry (URM) building constructed in 1917 with an architectural style termed “stripped classical”, that was assessed to be potentially earthquake prone according to the provisions of the Building Act 2004. Material testing and seismic assessment were conducted on the as-built structure and it was determined that Wintec F block had sufficient out-of-plane seismic strength for most of its walls, but that the building had insufficient in-plane seismic strength. Seismic improvement was proposed using a type of strain-hardening fibre reinforced shotcrete called Engineered Cementitious Composite (ECC) combined with steel reinforcement, and the building was strengthened to 100% of New Building Standard (NBS).

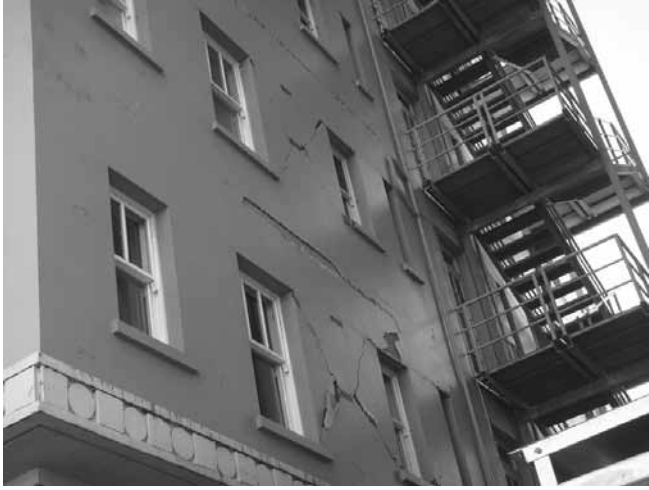
Figure 1. In-plane diagonal tension failure of a URM building caused by the 2010 Darfield Earthquake

Darfield earthquake (Dizhur et al. 2010a; Ingham and Griffith 2011), where many URM buildings exhibited in-plane diagonal tension failure (see Figure 1) or out-of-plane collapse of URM walls (see Figure 2).

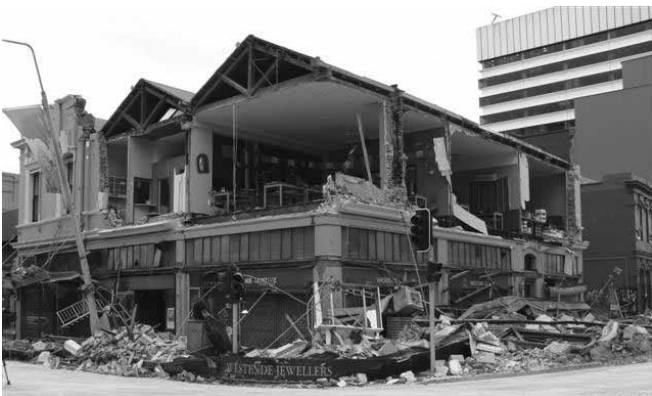
Figure 2. URM building with collapsed walls due to out-of-plane acceleration in the 2010 Darfield Earthquake

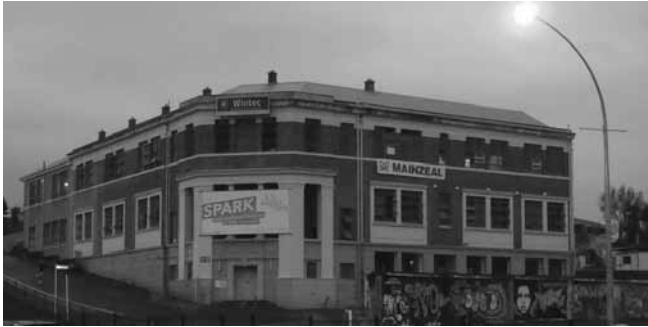
Figure 3. Wintec F Block

Two years later, Fraser High School was relocated to Ellicott Road and Waikato Technical Institute took over the remaining section of the building. Waikato Technical Institute is now known as Wintec, and the building it took over is now designated as F Block on the campus. Hence, the building is now known as Wintec F Block (see Figure 3) (Gibbons, 1977).

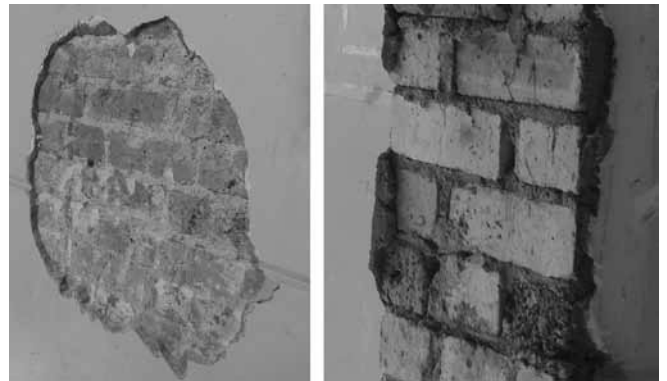
Figure 5. Masonry type observed in Wintec F Block

single bricks and three brick high masonry prisms extracted from the building site and tested in the laboratory. The masonry consisted of bricks with dimensions of

75 mm × 220 mm × 105 mm and mortar joints being 10 mm thick on average. Examples of the masonry type observed are shown in Figure 5.

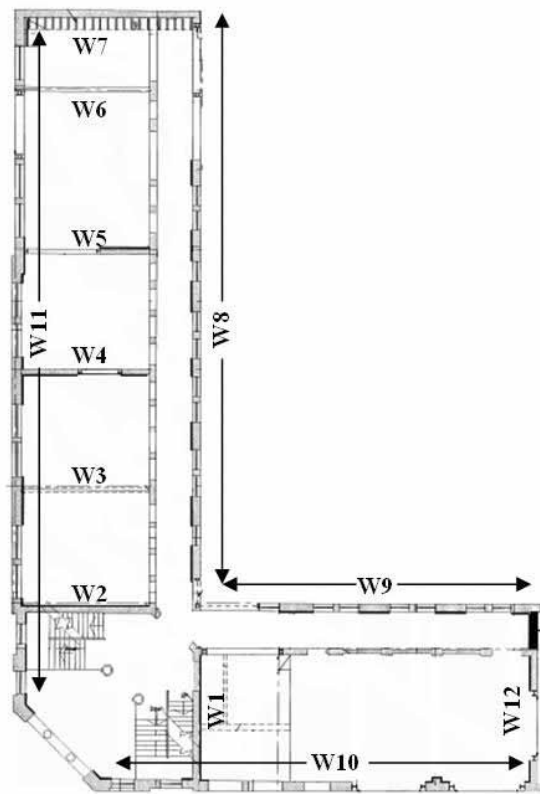
Figure 4. Building plan for Wintec F Block

to the wall thickness directly below it. Two types of bricks were used in the building, with the original bricks dense and of a yellow color, and the other type of brick being dense and dark red, which are located primarily on the second level of the building and presumed to have been used when the building was extended in 1934 and 1948. On the outside of the building dark red veneer bricks were used to cover the exterior surface, while on the interior most walls are covered with plaster to a thickness ranging between 10 to 15 mm. Roof and floor diaphragms inside the building are constructed of Matai timber and floor joists on the first level have the dimensions of 190 mm × 45 mm, with a spacing of 450 mm c/c. Multiple joists had previously become damaged by moisture and were found to be cracked and broken in several locations. On the second level, the floor diaphragms consist of timber joists with dimensions of 450 mm × 45 mm at the same 450 mm c/c spacing. The concrete extensions constructed in 1934 and 1948 are located at both ends of the "L" shape building (see Figure 4).

A number of three brick high single leaf masonry prisms were extracted from the interior wall W4 (see Figure 4) and tested in compression in accordance with ASTM 1314-00a (ASTM 2001b). Displacement gauges were incorporated during testing to obtain the stress-strain response and Young's Modulus values (E) as presented in Table 3. Figure 7 shows a masonry prism during testing. The average masonry compressive strength was 9.7 MPa, which is higher than the FEMA

Two out-of-plane URM wall tests were conducted on a non-load bearing, 2-leaf clay brick masonry partition wall (W3 in Figure 4). The wall had a 15-20 mm thick cement plaster finish on both sides, and had dimensions of 7.2 m long \times 3.9 m high (see Figure 8). In order to simplify the tests and to provide direct comparison to the results obtained from laboratory-built specimens and the assessment results based on NZSEE (2006), a 1250 mm wide strip of wall was isolated from the rest of the wall, thus inducing a one way bending failure. The location of the strip was selected adjacent to a door opening to minimise the length of required saw cuts as shown in Figure 9.

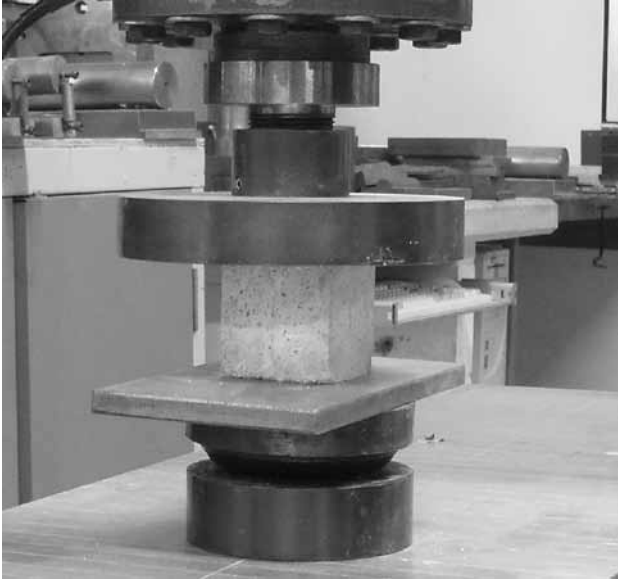
Figure 6. Mortar sample in testing

and in good condition. In internationally established standards such as ASTM C 109M-99 (ASTM 2001a), compression testing of mortar cylinders or 50 mm mortar cubes is recommended. Extraction of samples in such size and shape is unattainable in existing buildings as the mortar joint thickness is limited, and therefore irregular mortar samples were acquired, cut into measurable shape (36 mm long × 24 mm wide × 30 mm high) and tested in compression. Two extra samples having dimensions of 20 mm long × 20 mm wide × 30 mm high were also tested, and these results were found to be low compared to those of the larger samples. The results of mortar testing are shown in Table 2 and the test is shown in Figure 6. The high coefficient of variation was due to the low compressive strength of the smaller samples. The average mortar compressive strength was higher than the NZSEE recommendation for stiff mortar (8.0 MPa) (NZSEE, 2006).

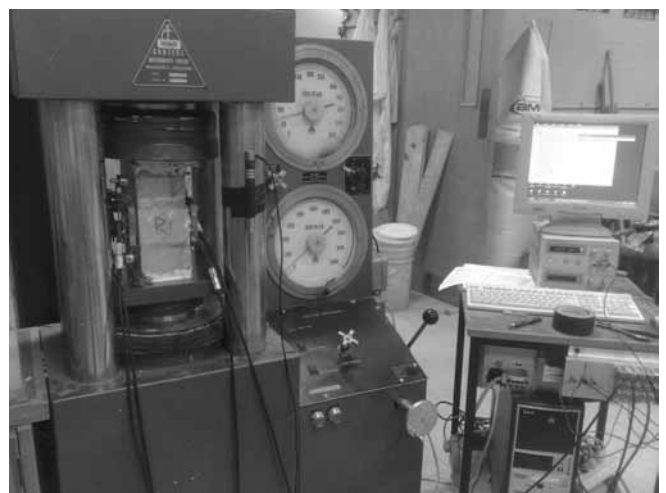
Figure 7. Masonry prism during testing

356 recommendation for masonry in good condition (6.2 MPa). However the average masonry Young's modulus (2.6 GPa) was lower than the FEMA suggested value of 3.4 GPa (FEMA, 2000). Comparison with the NZSEE (2006) guideline could not be made as the guideline does not provide the recommended values for masonry prisms.

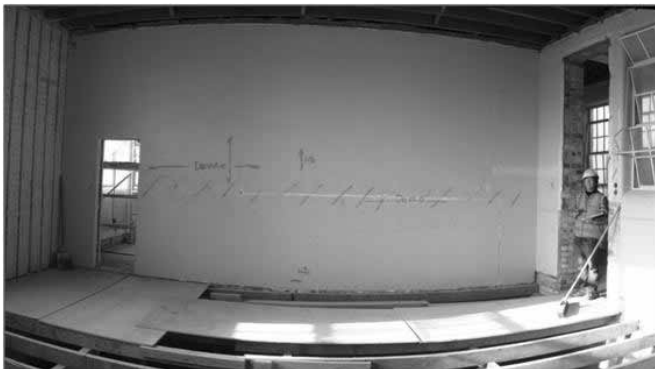
Figure 8. Panorama (distorted) view of Wall W3

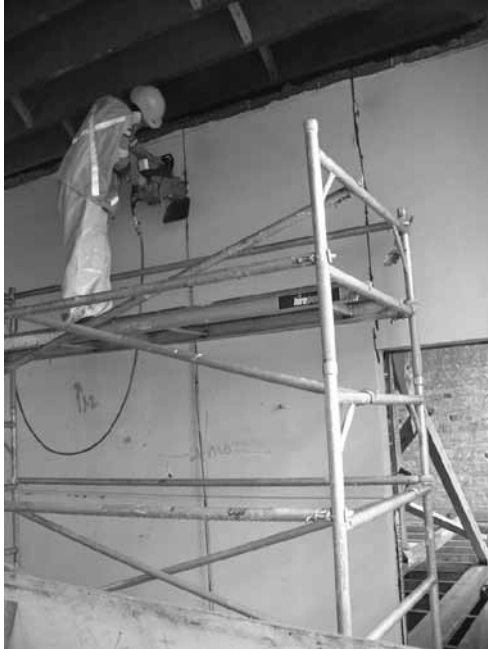
Figure 9. Cutting the wall strip using a masonry-cutting chainsaw

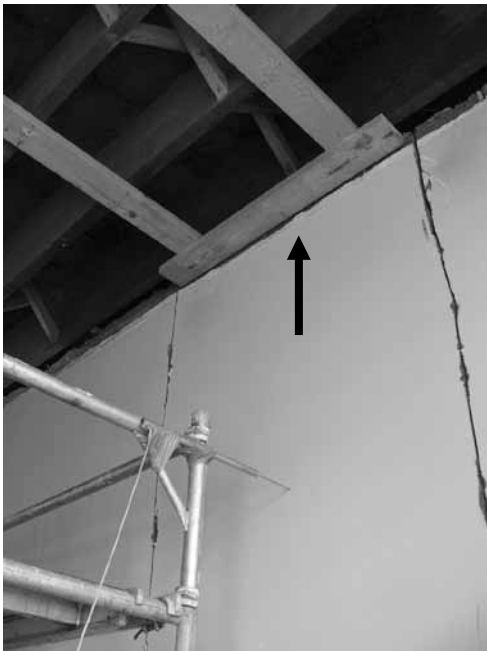
Figure 10. Timber support constructed for AS-SS test

Due to the presence of a concrete ring beam at the top of the wall, the as-built testing consisted of two schemes to investigate the effects of different boundary conditions. The first scheme (Test AS-CB) involved cutting the wall strip up to the concrete ring beam and testing with the continuous concrete beam extended across the wall strip. The second scheme (Test AS-SS) involved cutting the concrete ring beam, including all reinforcement, and providing an additional horizontal support at the top of the wall strip (connected to the first floor joists), resulting in a propped support at the top (see Figure 10). The experimental setup (see Figure 11) closely resembled that which Derakhshan et al. (2009) used to conduct laboratory out-of-plane testing on URM walls at the University of Auckland. Two Bigfoot vinyl airbags, measuring 2.1 m \times 1.2 m, were inflated to gradually apply the loading. Due to a reduction in the actual inflated airbag area resulting from the rounded geometry of the airbag edges, the recorded applied force was observed to be between 80% to 85% of that calculated using airbag pressure and gross loaded area (deflated airbag area). The plywood backing, measuring 2.4 m \times 1.2 m, consisted of an assemblage of timber sheets and steel angles, and was supported by a reaction frame. As the diaphragm was incapable of resisting the generated forces, timber planks were used underneath the setup frames (Figure 11) to distribute the reaction force on the diaphragm surface and to partially transfer the reaction forces to the opposite wall foundation.

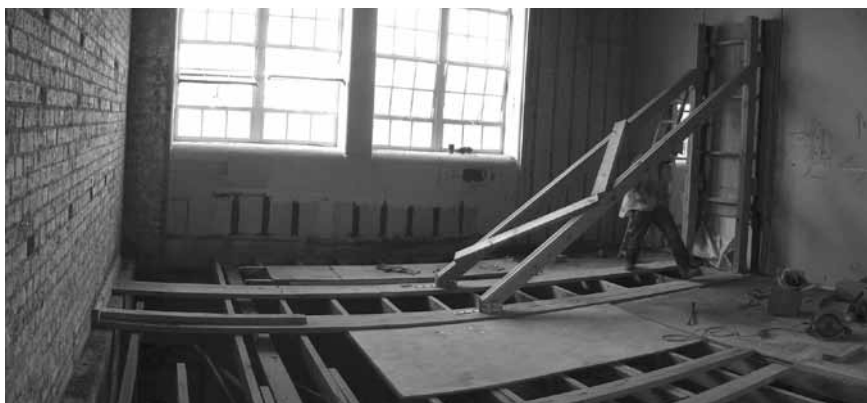
Figure 11. Reaction frame constructed for out-of-plane testing

The reaction forces were transferred to the reaction frame using four load cells, and to ensure that the entire force was transferred through the load measuring devices, frictionless plates were used underneath the plywood backing. Out-of-plane displacement was measured using two Linear Variable Differential Transducers (LVDT) mounted on the opposite side of the wall, with one LVDT placed mid-height and one at

the wall centerline. The data from load cells and LVDTs were collected at 50 Hz frequency using a National Instruments data acquisition system.

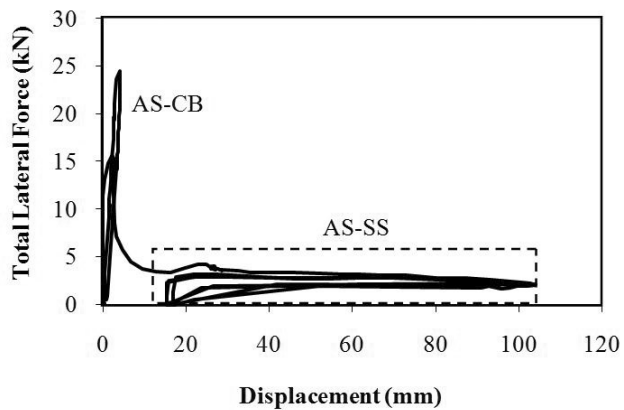
Figure 12. Force-displacement graph

During Test AS-CB no cracking was visually detected on the wall surface, although the lateral force was increased up to approximately 24 kN. Consequently, the obtained results for test AS-CB were all in the elastic range (see Figure 12).

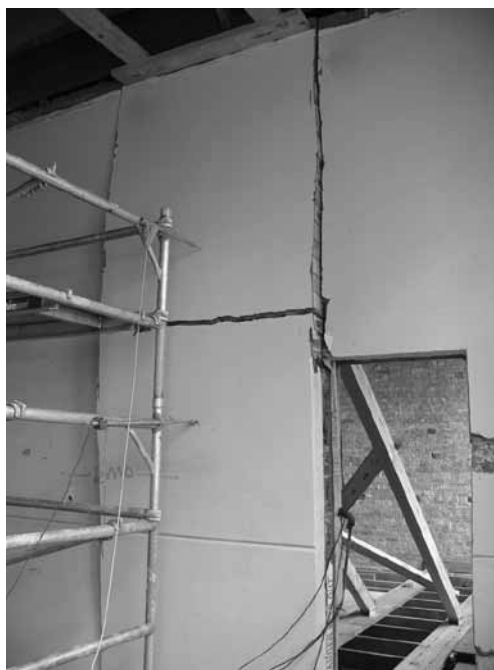
Figure 13. Wall crack during the AS-SS test

Testing of AS-SS resulted in a single horizontal crack at 56% of the wall strip height (see Figure 13) above the base, with the crack location being consistent with the laboratory testing previously conducted by Derakhshan et al. (2009). The test was continued, and in three semi-cycles of loading, a maximum lateral wall mid-height displacement of 105 mm was measured. The resulting force-displacement history of the three semi-cycle loading (shown in the dashed box in Figure 12) is isolated and shown in Figure 14, showing good correlation between the experimental results and a bilinear model previously obtained following laboratory tests reported by Derakhshan et al. (2011). The wall strip had a 19 mm residual displacement after the completion of test AS-SS. Full details of the testing can be found in Dizhur et al. (2010b).

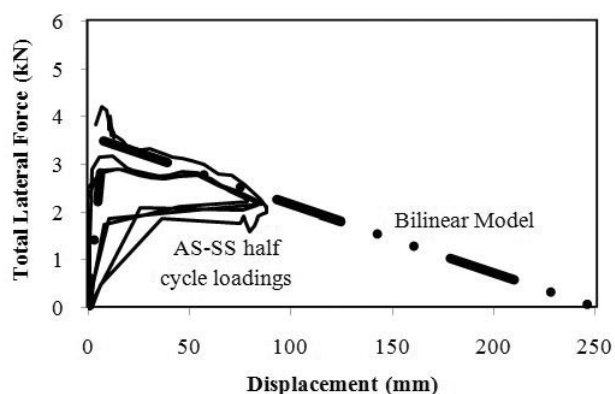
Figure 14. Wall post-cracking behavior

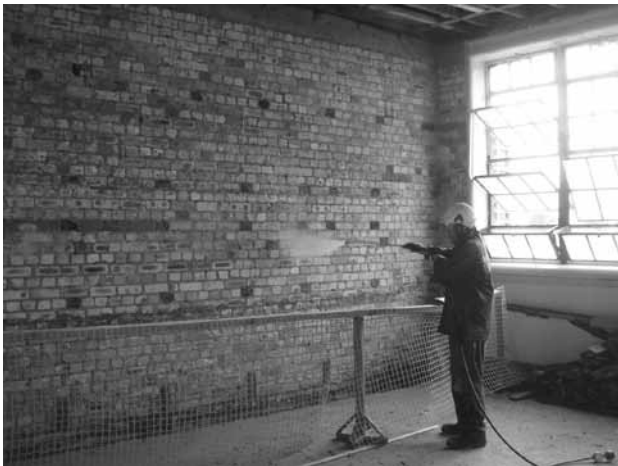
Figure 16. Water-blasting of masonry surface to prepare for shotcrete

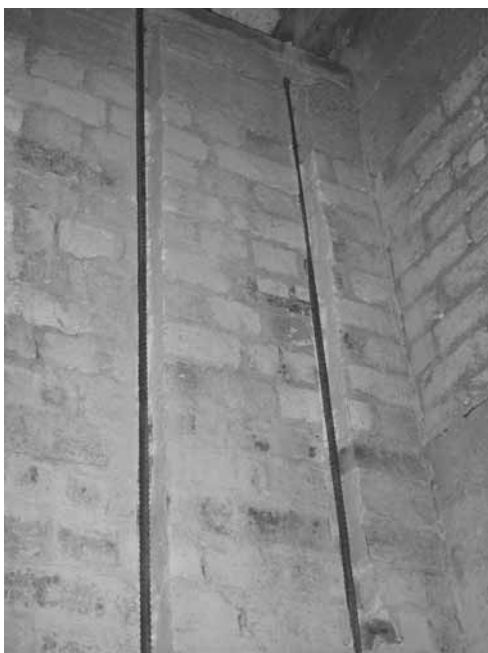
Figure 17. NSM steel reinforcing bars

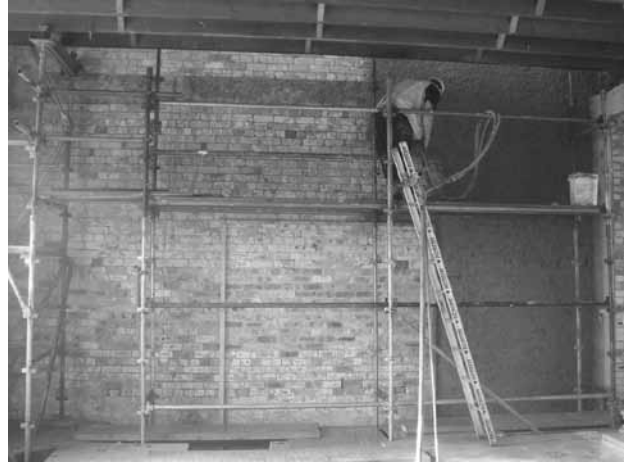
Figure 18. Shotcreting of W4

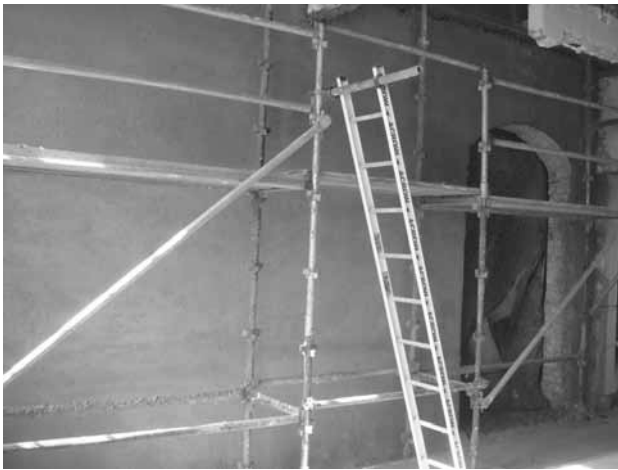
Figure 19. W1 after shotcreting
