Severe damage to Manchester Courts

By Jason Ingham and Michael Griffith

Overview

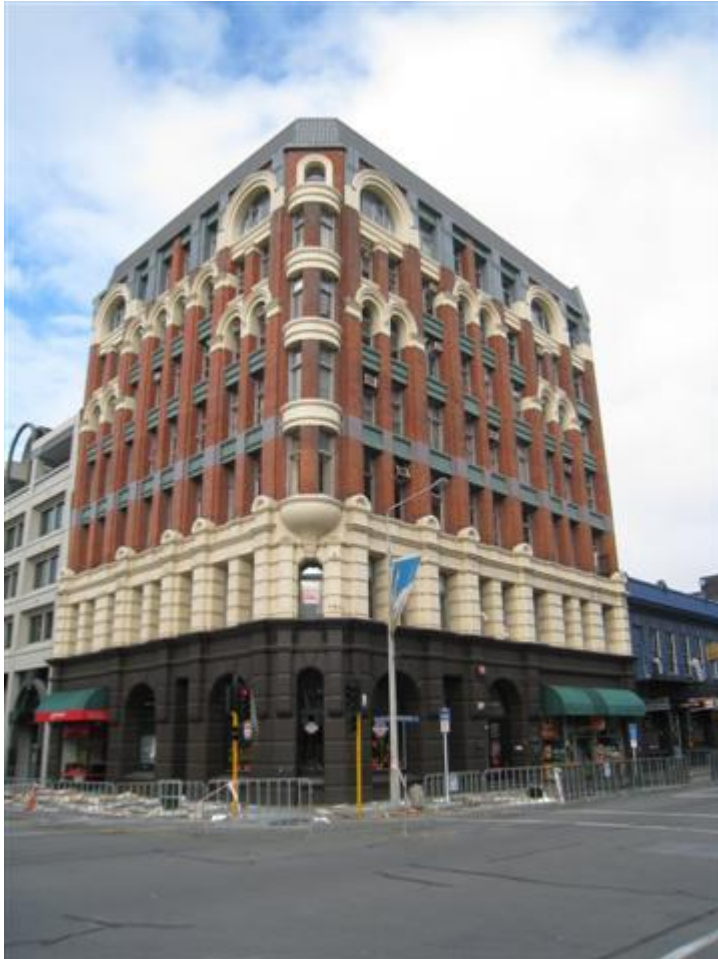
160 Manchester Street is a 7-storey load bearing masonry office building and the most significant, in terms of height, masonry building in Christchurch. It has a heritage order on it and is a significant part of the fabric of the Christchurch city landscape. Unfortunately, it suffered significant damage in the earthquake. According to the New Zealand Historic Places Trust (refer <http://www.historic.org.nz/TheRegister/RegisterSearch/RegisterResults.aspx?RID=5307>) the bottom two stories are reinforced concrete while the top five stories have load bearing unreinforced masonry piers around the exterior of the building and steel frame internally (columns spaced roughly at 5 m) with timber floors throughout. The masonry piers, having dimensions of approximately 1200 x 900 mm, were badly cracked at levels 3 and 4. This was most likely due to the transition from concrete to masonry at level 3 and the fact that the adjoining 2-storey building was along the southern wall side stopped providing lateral support at that level. It appears that the lift core had received some strengthening at some point, perhaps in the late 1980s as reported on the Historic Places website. Close up photographs of the masonry piers at levels 3 and 4 show the primary damage that concerned the assessment teams. The cracks were observed to open up with subsequent aftershocks. On the Monday (day 2), structural engineers met with Urban Search and Rescue Team leaders and city officials to determine a strategy for making the structure safe enough for building contractors and engineers to enter to determine more fully the extent of damage and the viability of repair. By day 3, the building had suffered three M5.4 and one M5.1 aftershock which induced further damage. At the time of writing, it appears that the building will have to be demolished. As it stands, it poses a significant falling hazard for buildings within 70 m in all 4 directions. This has resulted in all

the buildings within this distance being closed to the public (red-tagged) as well as both main streets (Manchester and Hereford) that run adjacent to the building.
