EARTHQUAKE-DAMAGED UNREINFORCED MASONRY BUILDING TESTED IN-SITU

Figure 2. Allen's Trade Complex B-East building

Figure 3. B-East building damage due to 2007 Gisborne earthquake

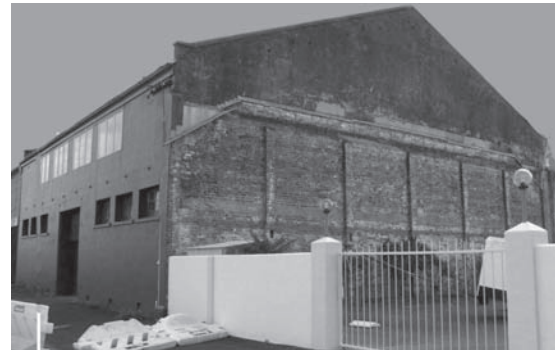
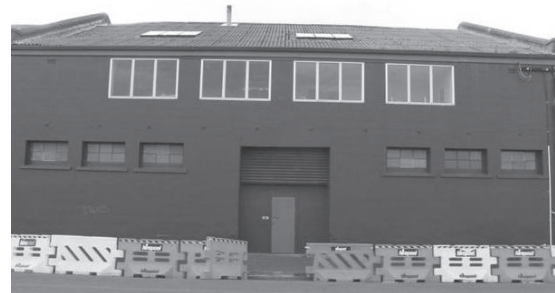
The 2 storey building (shown in Figure 2) is located in the CBD of Gisborne, New Zealand, and was originally constructed of unreinforced masonry with perimeter walls comprised of 2 to 4 leaf thick solid masonry. The

building has an almost square footprint of approximately 390 m². The first level floor diaphragm is constructed from timber joists and timber tongue and groove flooring and the roof of the building is a single gable constructed from timber framed trusses clad with corrugated iron sheets supported on wooden rafters. Both the roof and the floor diaphragms are connected to the perimeter walls using through steel anchors. The main masonry type for the original building consisted of red coloured soft bricks with soft lime/cement mortar.

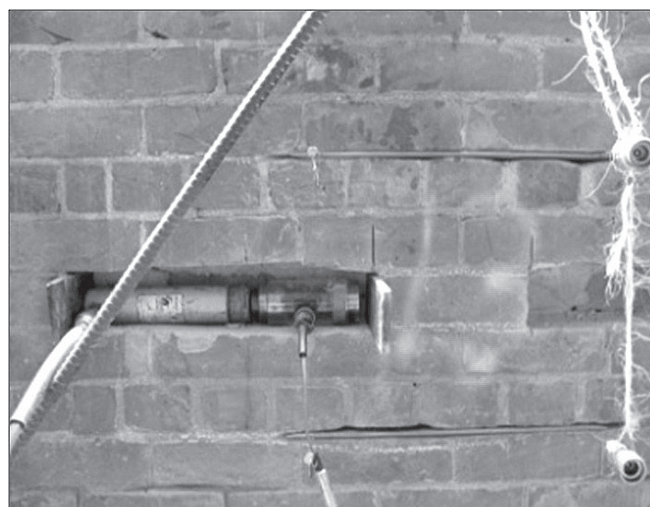
Figure 4. Typical mortar bed joint shear test setup

The mortar bed joint shear strength was determined on-site using the in-situ shear test procedure ASTM C 1531-03 (ASTM 2003b) as shown in Figure 4. A total of ten in-situ shear tests were performed, with four tests performed on the northern gable and six tests performed on the southern gable. Flatjack devices were then used to apply axial precompression load during tests 2, 3, 5, 6, 9 and 10. The shear test results are presented in Table 3.

The data reported in Table 3 indicates that the average mortar bed joint shear strength of the southern end gable was significantly lower than that of the northern end gable.

The significant difference in the mortar bed joint shear strength was attributed to a higher level of deterioration of the mortar joints in the southern gable than that in the northern gable and to the possible variation in mortar mixes during wall construction. It was observed that the bed joint shear strength was not significantly affected by variations in the axial precompression stress.

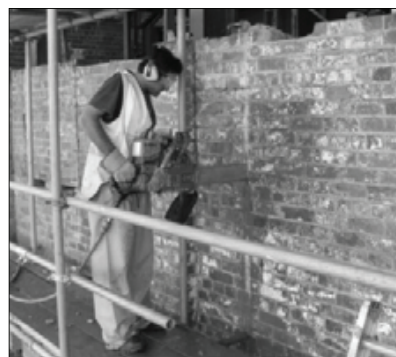
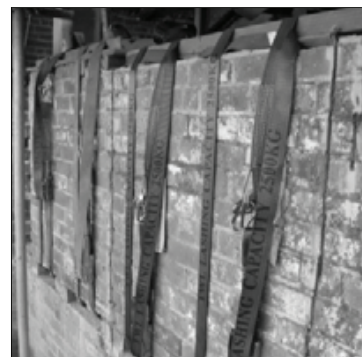
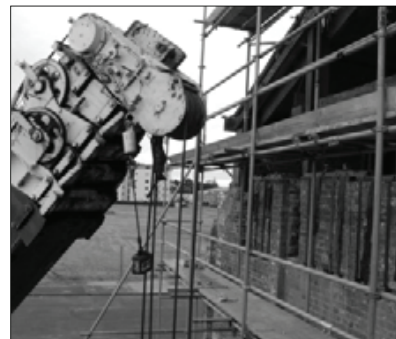
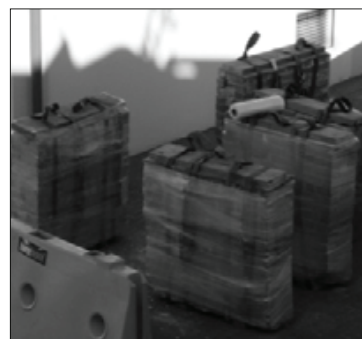
Figure 5. Wall panel preparation and extraction

The locations of the wall panels were carefully selected to minimise the required length of masonry cutting, the cutting locations were clearly marked, and the vertical cuts were made using a concrete cutting chainsaw. In order to extract the wall panels, two through penetrations per panel were made to allow lifting straps to be used. To prevent the panels from cracking or breaking during lifting and/or transportation, each wall panel was vertically strapped with two heavy duty ratchet tie downs. This secured the masonry together by applying axial force to minimise the risk of damage. Once the cutting and securing work was completed the wall panels were lifted out of the building and onto a truck using a medium sized crane, and transported to the University of Auckland in an undamaged condition. Wall panel preparation and extraction is shown in Figure 5.

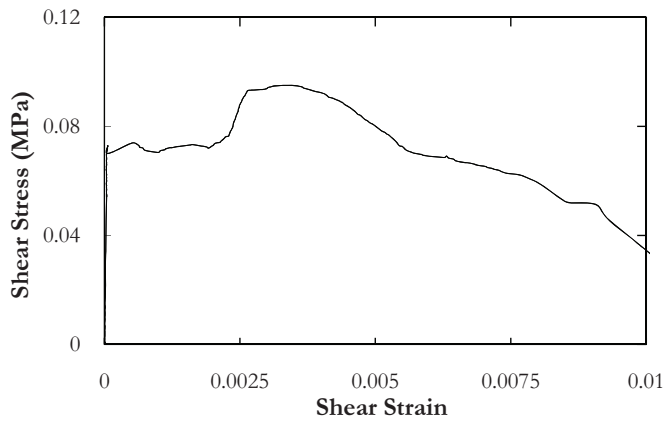
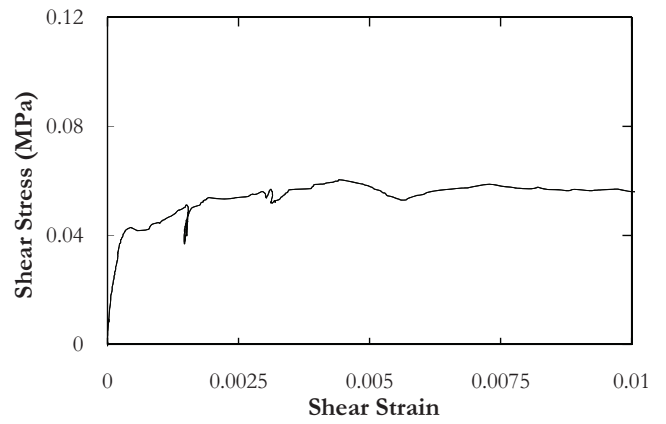
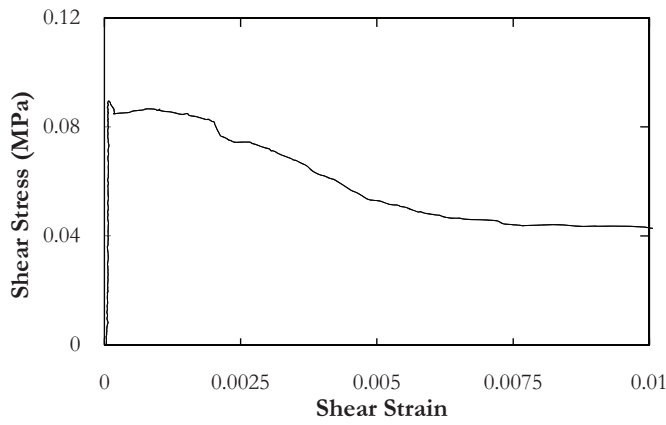
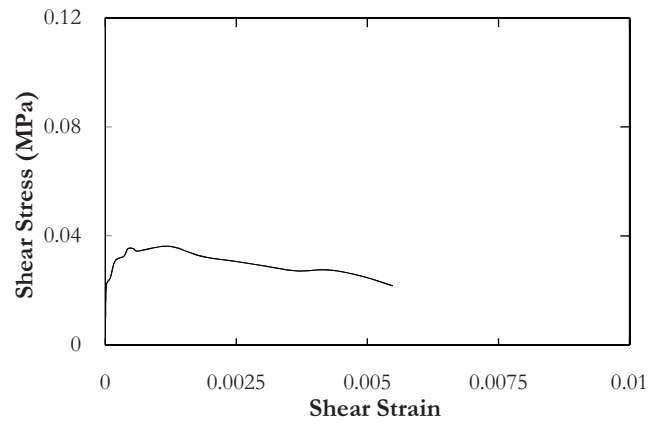
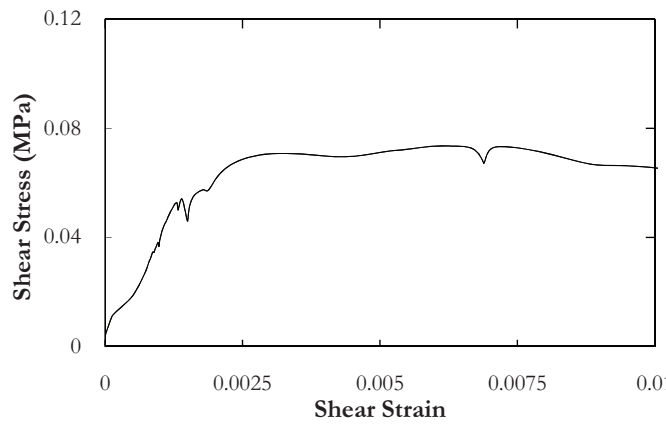
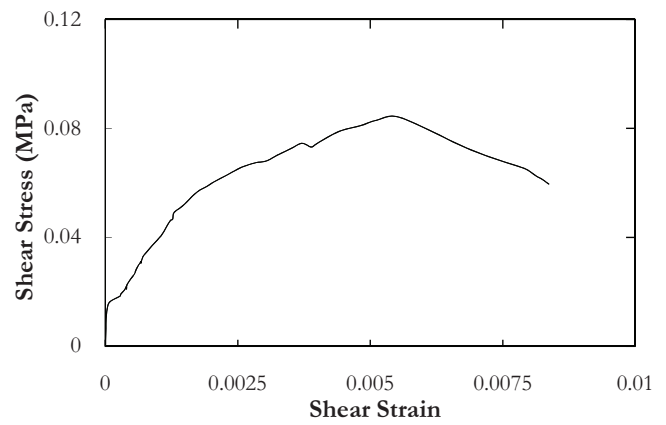
Figure 8. Shear response for wall panels in tested diagonal tension (shear)

All wall panels failed by crack propagation through the mortar joints in a step-wise mode, with the final crack patterns illustrated in Figure 7. In order to provide direct comparison to the results obtained from laboratory-built wall panels, and to facilitate interpretation and use of the data by structural engineering practitioners, the wall panel displacements are reported as shear strain as shown in Figure 8. It is noted that test panel AGW4 (as-built Gisborne wall panel 4) suffered minor damage during the setup preparation in the laboratory, resulting in the sample being pre-cracked at the 7th brick course from the bottom. This is visible in the crack pattern shown in Figure 7(b) and is responsible for the reduction in shear stress at cracking that is illustrated in Figure 8(d).

The diagonal shear strength varied among the tests, but within reasonable limits for URM construction. With the exclusion of the pre-damaged wall panel AGW4

the average shear stress at cracking was 0.057 MPa, with a maximum average shear stress of 0.082 MPa. The crack pattern observed at failure closely matched the pattern obtained in laboratory-built wall panels with weaker mortar mixes (Russell 2010). For all wall panels, with an exception of AGW3, the maximum shear stress was higher than the shear stress at cracking, which was not observed in laboratory-built samples where shear stress decreased immediately following cracking (Russell 2010). The results presented in Table 4 enable a comparison of the results from laboratory-built wall panels constructed using different mortar mixes to wall panels extracted from the B-East building. The results from wall panels manufactured in the laboratory with 1:2:9 mortar mix (cement:lime:sand) closely resemble values obtained from the B-East building wall panels. The average maximum shear stress for the laboratory-built wall panels using a 1:2:9 mortar mix was 0.094 MPa, which compares well to the 0.082 MPa mean value obtained from the B-East building wall panels. Laboratory built wall panels using a weaker mortar mix of 0:1:3 and a stronger mortar mix of 2:2:9 resulted in maximum shear stresses of 0.04 MPa and 0.50 MPa respectively, which were outside the range obtained from wall panels from the B-East building.

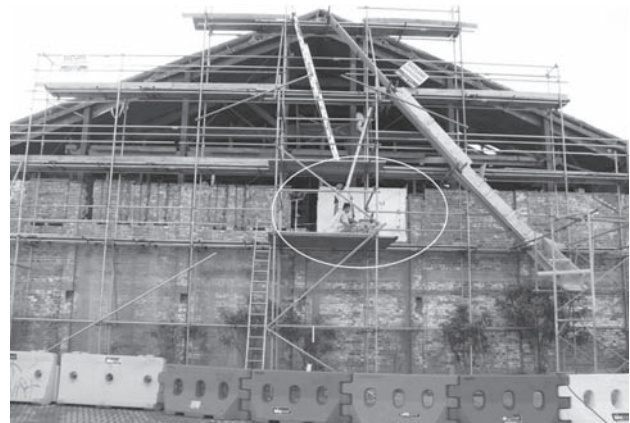
Figure 9. In-plane push test location, southern gable

The test wall location was selected to have a maximum possible length, which was constrained by the location of masonry columns. The selected location was on the first level of the building as illustrated in Figure 9. The test section was isolated from the rest of the wall by vertical cuts on both sides of the section and had dimensions of 2.6 m long × 1.3 m (17 bricks) high × 0.33 m (three leaf) wide, with no additional axial load applied apart from the wall self weight. The wall was painted white to facilitate visual detection of formed cracks during the test.

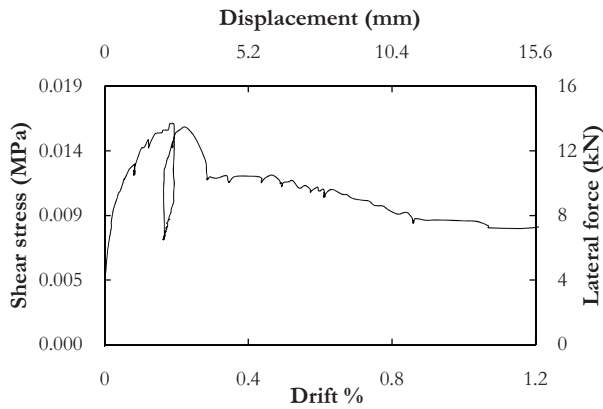
Figure 12. Base shear - drift response for in-plane push test

Initial cracking was observed at a displacement of approximately 2 mm (0.5% drift) with a corresponding base shear of 9.1 kN. With increasing loading the crack propagated from the loading side in a step-wise pattern through mortar joints and sliding of the section occurred, with the final crack pattern being as shown in Figure 11. The base shear-drift response is shown in Figure 12. Only the displacement values obtained from the top LVDT are reported here.

During the test it was observed that the crack initiated at the loaded edge of the wall and gradually propagated to the opposite edge, indicating that the cohesion was engaged with the increasing load levels as indicated by the changing gradient between 0 and 0.2% drift for the curve shown in Figure 12. Based on simple static analysis, the applied force and the normal force due to the self weight of the test section acting on the sliding plane resulted in the coefficient of friction μ for the wall section being calculated to be 0.7.

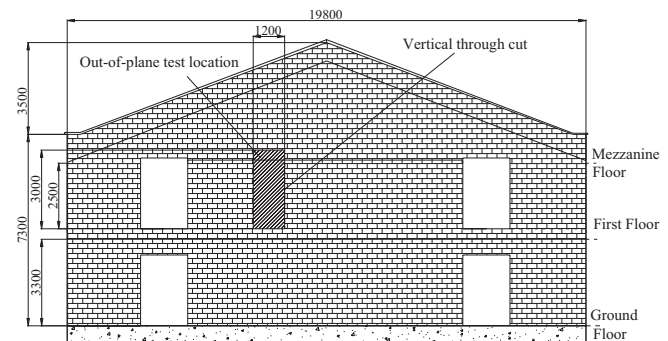
Figure 13. Southern gable elevation showing test location

Two out-of-plane wall tests were conducted at the B-East building, one being in the as-build condition and one in the retrofitted (repaired) condition. A 2-leaf wall lined with 12-15 mm thick cement plaster finish on the exterior surface was selected for testing and was located within the southern gable as shown in Figure 13. The entire wall had dimensions of 19.8 m long \times 10.8 m high with two door penetrations. In order to simplify the test and to provide possible comparison to laboratory-built specimens, a 1200 mm wide wall strip was isolated from the rest of the wall, inducing a one way bending failure. The wall strip was isolated by cutting vertically through the wall using a concrete cutting chainsaw, with vertical cuts made on an inward angle to eliminate wedging effects after wall deformations had occurred. Due to the presence of the mezzanine floor the maximum possible height of the wall strip was restricted to 3000 mm.

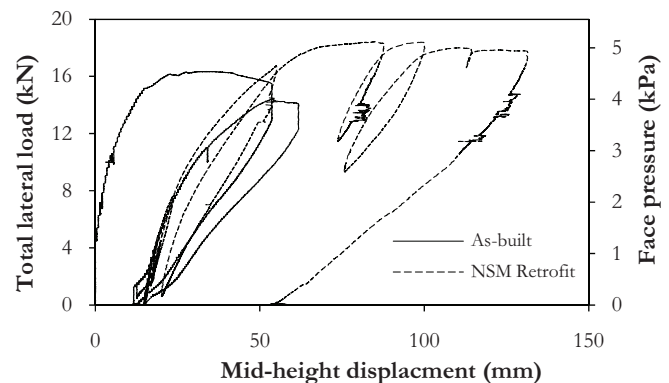
Figure 18. Total lateral force-displacement response for out-of-plane as-built and NSM repair tests

releasing the airbag pressures) so that crack locations could be observed and marked at different stages throughout the test. Numerous new cracks formed in the vicinity of the strip and the final crack pattern is illustrated in Figure 19. The pressure in the airbag was increased until a total mid-height displacement of 130 mm was reached. At this displacement substantial wide cracking of the masonry above the tested wall strip had occurred (shown in Figure 19 (c)) and due to safety considerations the pressure in the airbag was not further increased. The total lateral load – mid-height displacement response is shown in Figure 18.

The location of crack formation at 53% of the strip height during the as-built test was comparable to the results obtained during laboratory testing of walls with similar geometry (Derakhshan et al. 2010). It is clear that the boundary conditions that are encountered in real buildings are different from those simulated in the laboratory. For the testing reported here the boundary condition at the top of the test wall restrained upward movement and resulted in arching action that caused cracks in the gable above the wall strip edges that propagated at approximately 45° angles away from the wall strip corner. In the second semi-cycle, shown in Figure 18, due to the pre-existing cracks, the level of overburden had decreased and resulted in a 16% reduction in total lateral strength.

A single CFRP NSM strip was shown to increase the post-cracking wall strength, as illustrated in Figure 18, the wall strength increased by approximately 35%. Due to a large number of newly formed cracks it is clear that there was a larger amount of energy dissipation occurring compared to the as-built condition. Even though further research is required to accurately establish the design guidelines for this type of seismic retrofit, this and previous testing have illustrated that this retrofit technique provides a simple and cost effective alternative to seismically strengthen URM buildings and their components.

Following the as-built test the wall test section was retrofitted (repaired) using a single 15 mm wide and 1.2 mm thick CFRP strip (Modulus of Elasticity of 165 GPa) positioned vertically in the centre of the wall test section and extending from top to bottom, as shown in Figure 17(b). A groove was cut into the brick through the plaster layer, using a diamond blade circular saw (5 mm thick blade) to a depth of approximately 30 mm to ensure direct bonding of the CFRP strip to the brick surface only. Two part epoxy adhesive was used to bond the CFRP strip into the groove. The groove was entirely filled with epoxy prior to CFRP strip insertion to ensure maximum bond area, and 24 hours were allocated for the epoxy to set. Figure 17 shows the installation procedure.

Following the completion of as-built wall testing, a CFRP NSM retrofit (repair) was applied, with the repaired wall tested using the same setup and boundary conditions as used for the as-built test. The pressure was increased until visible cracking within the vicinity of the strip occurred, and the airflow was then paused (without
