# IN-FIELD SIMULATED SEISMIC TESTING OF AS-BUILT AND RETROFITTED UNREINFORCED MASONRY PARTITION WALLS OF THE WILLIAM WEIR HOUSE IN WELLINGTON

By: Hossein DERAKHSHAN<sup>1</sup>, Dmytro DIZHUR<sup>2</sup>,  
Ronald LUMANTARNA<sup>3</sup>, John CUTHBERT<sup>4</sup>,  
Michael C. GRIFFITH<sup>5</sup> and Jason M. INGHAM<sup>6</sup>

**Figure 2. WW wing building plan - level 3 (provided by Dunning Thornton Consultants Ltd)**

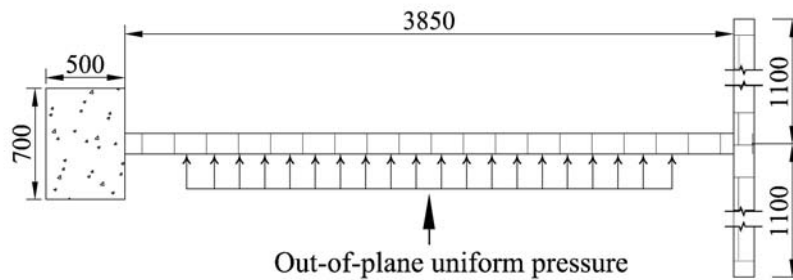
**Figure 3. Wall C8-C9 plan**

Partition walls B3-B4 and B17-B18 had similar boundary conditions, with both walls connected to reinforced concrete elements at one end and to a masonry return wall at the other end and to concrete floors below and above the wall. Similarly, wall C8-C9 was connected (Figure 3) to a reinforced concrete column at one end, to a masonry return wall (2200 mm long) at the other end, and was constructed on a reinforced concrete floor. Wall C16-C17 had similar boundary conditions to C8-C9, except that the reinforced concrete column was replaced by a reinforced concrete shear wall and a timber wardrobe that contributed to the wall end support as shown in Figure 4.

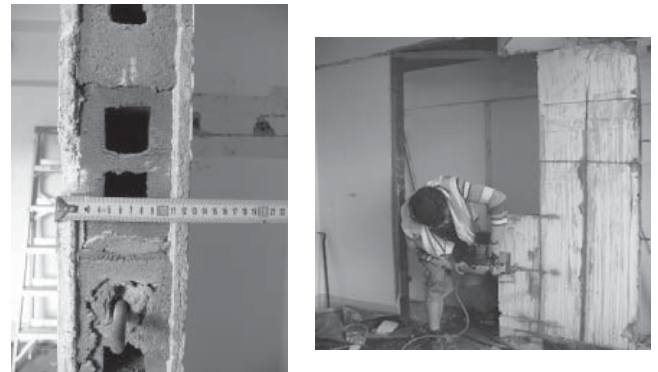
**Figure 6. Partition walls**

The walls were constructed from dark red hollow clay bricks and cement mortar, with plaster on both surfaces as shown in Figure 6a. The masonry units measured on average 160 mm x 300 mm x 95 mm, and the average mortar joint thickness was 15 mm.

(a) Partition wall cross section (b) Masonry prism extraction

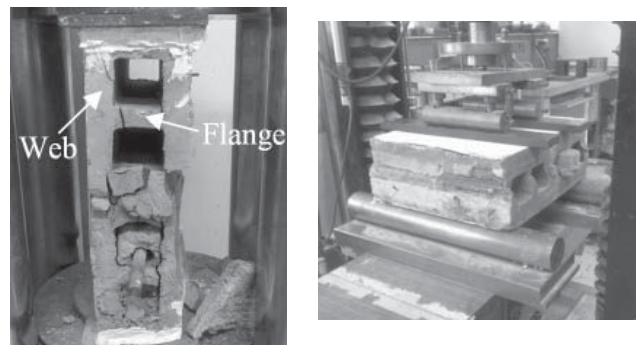
**Figure 7. Material testing**

of the masonry prisms tested in compression was brittle and was mainly initiated by the propagation of vertical cracks through the web-flange joints (see Figure 7a). The four point bending tests were performed with two point loads spaced at 130 mm about the centre of the test specimen, and the roller supports were located at 300 mm apart. The mid span deflections were measured using an LVDT device attached on the test machine. One of the flexural bond test samples failed through the brick web instead of the mortar joint, and yet it was the weakest among the total of three samples tested. The remaining samples failed through the mortar joints and the flexural bond test results confirmed that the brick-mortar bond of this building is much stronger than those of other buildings (Derakhshan et al. 2010b) investigated by the research team. The plaster compressive strength ( $f'_p$ ) was determined through compression tests of irregular plaster samples (average length, width and height of 26 mm, 21 mm and 26 mm respectively), and the measured mid span deflections were used to estimate the flexural rigidity property of the masonry prisms ( $EI$ ) using elastic beam bending theories.

(a) Prism compression test (b) Flexural bond test

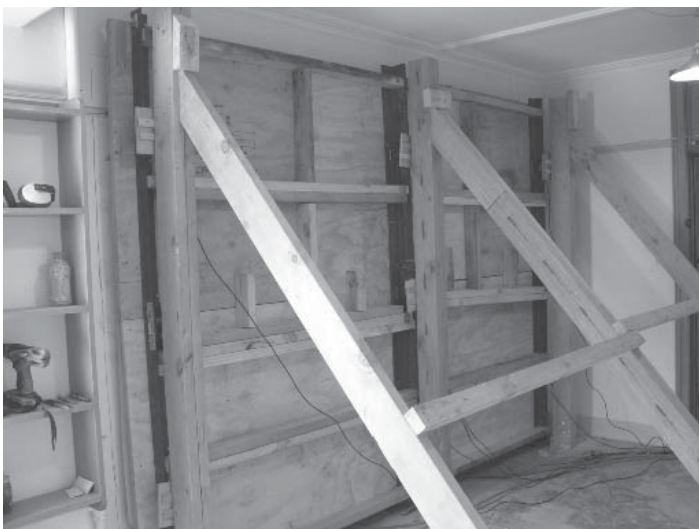
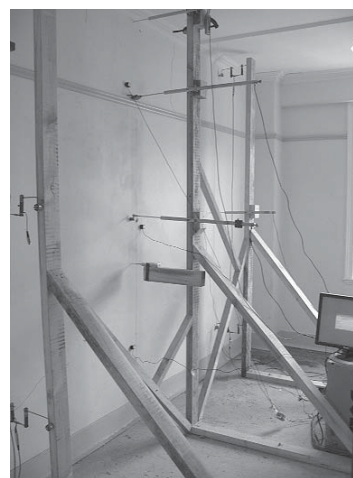
**Figure 8. Test setup**

The test setup (Figure 8) consisting of a timber backing frame and timber diagonals, which were assembled and fixed to the concrete floor. Bigfoot™ vinyl airbags with a skin thickness of 0.25 mm were placed in a gap of 100 mm between the wall surface and the backing frame and gradually inflated to generate out-of-plane uniform forces on the wall surface.

(a) Airbag backing and supporting frame

(b) Wall instrumentation
