Comparing New Zealand's Unreinforced Masonry Details with those of Other Seismically Active Countries

ABSTRACT

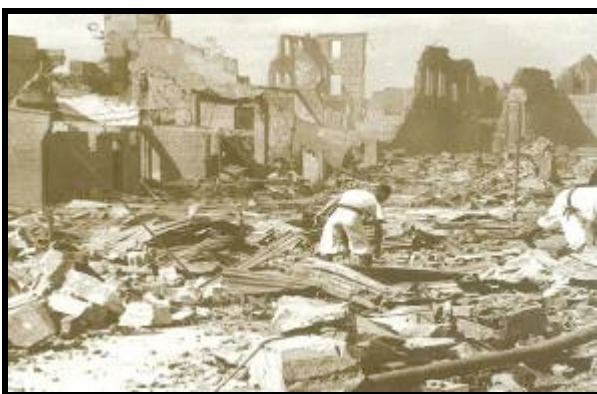
Figure 1 Damage to URM buildings in Napier earthquake 1931 (reproduced from [30])

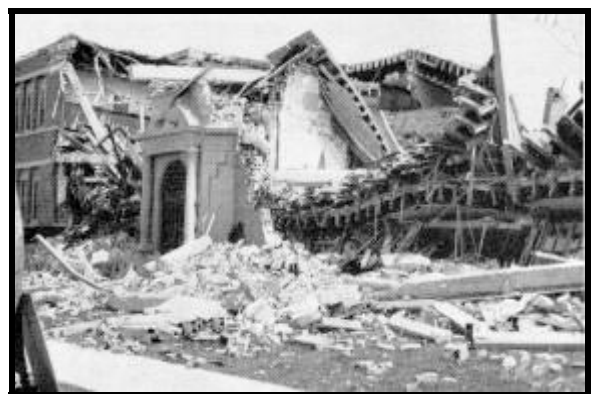
Figure 2 The collapse of part of Jefferson Junior High School in Long Beach 1933 (reproduced from [31])

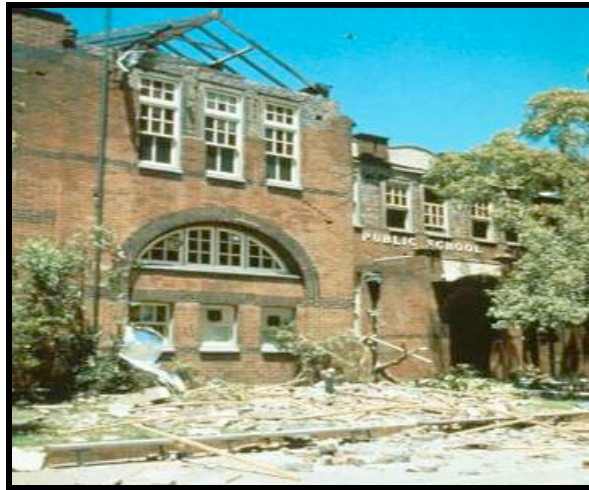
Figure 3: Damage to URM school building in the 1989 Newcastle earthquake (reproduced from [32])

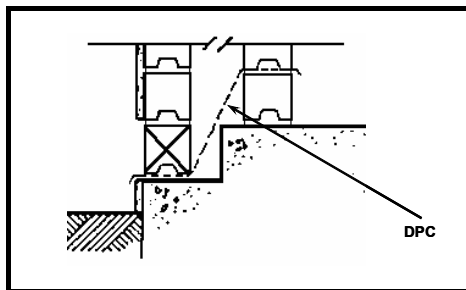
Figure 4 URM wall to ground floor slab DPC connection detail

The second most common detail of concern is related to an in-plane sliding shear failure mode at the base of ground storey walls. The use of damp-proof courses (DPC) at the base of URM buildings (see Figure 4), to prevent moisture being sucked up from the ground into the brickwork, means that transfer of seismic shear force at the base of the building is completely due to friction. It is not clear that this failure mode is actually a life-safety issue, given the relatively small amplitude of ground displacements likely to occur in Australia; however, in the current codified procedure it is a strength check which many of the typical buildings do not satisfy. The DPC joints are normally along a constant horizontal plane.

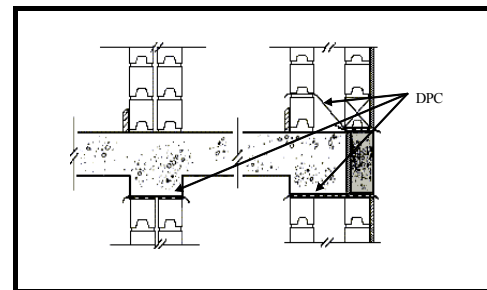
Figure 5 URM wall to inter storey floor slab DPC connection detail

Finally, the third most common potential failure mode is through the wall (thickness) shear failure at the base of exterior walls in the upper levels of a building. This again is due to the use of a DPC or slip joint detail which limits the in-plane stresses induced in a URM wall due to differential concrete slab shrinkage and clay brick growth. However, in URM walls at the top of a building, where the out-of-plane accelerations are greatest, the typical coefficients of friction of about 0.3 are limited in the magnitude of shear reaction in the "through the thickness" direction that they can accommodate. If on average the out-of-plane acceleration is greater than 0.3g, then there can be a problem. See Figure 5.

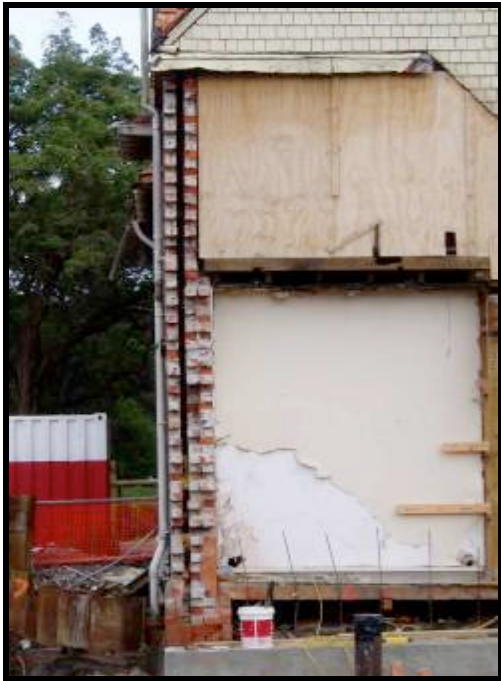
Figure 6 New Zealand multi-leaved wall with change in wall thickness at floor level

Unreinforced masonry buildings in New Zealand can be of either one- two or multi-leaf construction. Figure 6 shows a double leaf wall. Usually the outer leaf is simply for weather proofing, and serves little structural purpose, while the inner leaf is structural. In external walls, it is important that the leaves are connected adequately to combat out-of-plane accelerations in the façade or outer leaf. It has been identified that in many instances these ties were never put in place as part of the original construction, or if they were they are now completely rusted out. Also, due to erosion of the building, the mortar in the walls is often now in poor condition. Wire ties were often placed in the mortar between

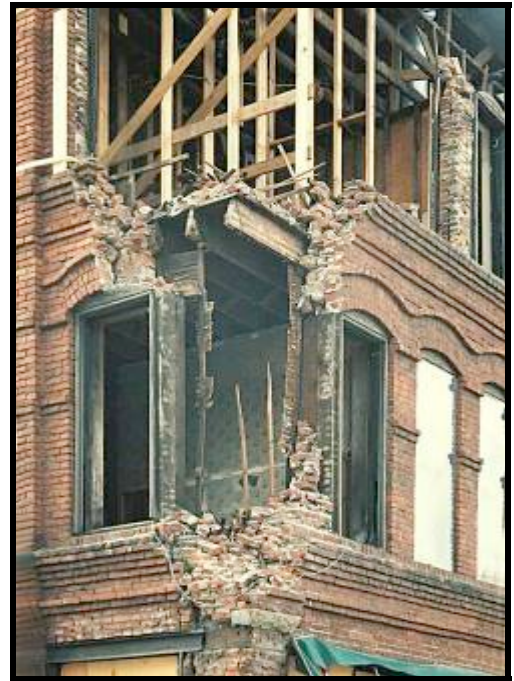
Figure 7 Cross-section of brick masonry wall in The United States (reproduced from [33])

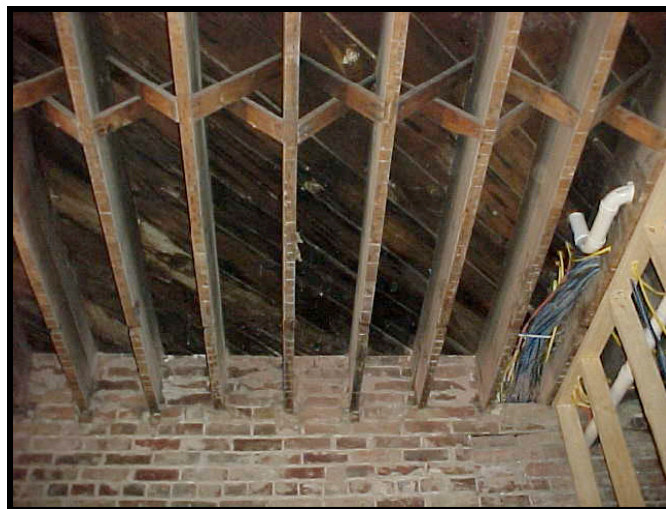
Figure 8 Connection between floor joists and URM wall in US (reproduced from [34])

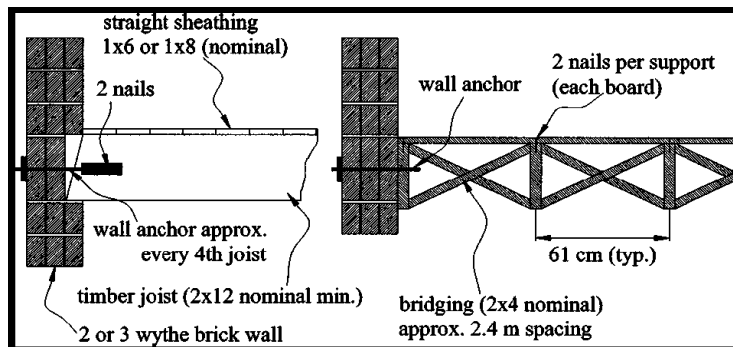
Figure 9 Typical floor connection details in pre-1950s URM buildings in US (reproduced from [25])
