# Critical earthquake risk detailing in New Zealand's multi-storey building stock: understanding and improving the current perception

2006 NZSEE  
Conference

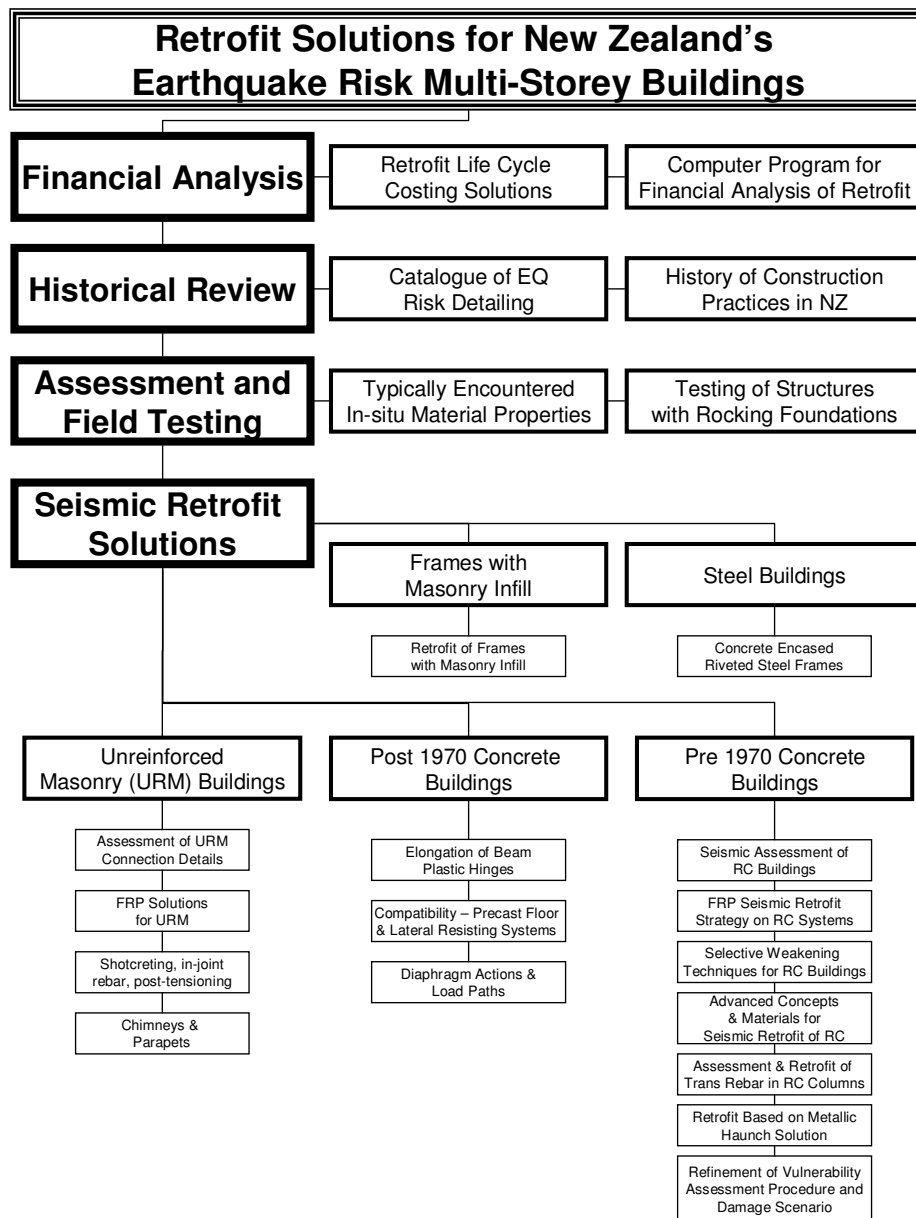
Figure 1 Retrofit Solutions for New Zealand's Earthquake Risk Multi-Storey Buildings – Project Overview as at March 2006

Figure 1 schematically illustrates the project overview as at March 2006. More details can be found on the project website ([www.retrofitsolutions.org.nz](http://www.retrofitsolutions.org.nz)).

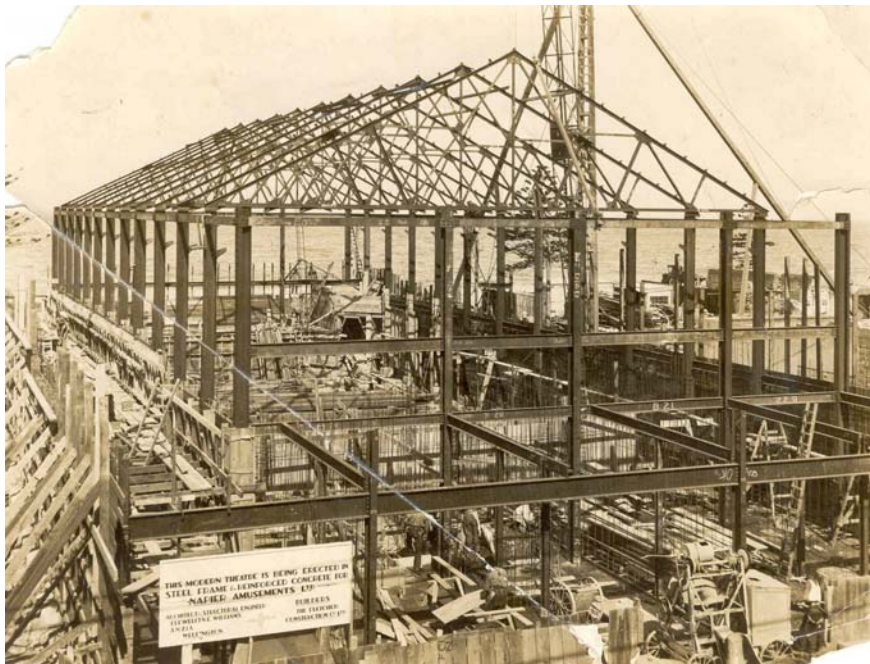
Figure 2 1932 construction of a buildings having a riveted steel frame encased in concrete

Between approximately 1910 and 1940, construction using concrete encased riveted steel frames (CERSF), was a common practice both in New Zealand and in many other parts of the world, especially for monumental and institutional buildings (see for instance Figure 2). The popularity of this construction technique partly derived from building regulations that limited unreinforced masonry buildings to a height of five storeys. Furthermore, many large buildings such as train stations and hospitals required large wall openings for building operation, suiting steel construction rather than masonry. This method of construction was also very popular in other earthquake prone areas such as San Francisco, and many of the examples in New Zealand were in fact designed overseas.

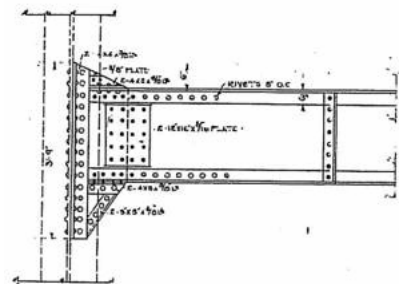
Figure 3 Riveted steel beam-column joint on column weak axis

The detailing used in these buildings has been found to be quite generic, with the steel providing almost all of the strength. It is thought that the primary attribute of the concrete encasement is for fire protection of the steel frame, and there is debate over how much strength the concrete provides. Section C5.8 of FEMA 356 (2000) recommends ignoring any strength that the concrete may provide, whilst designers have commented that as the concrete encasement exists, it is important to understand its influence on structural performance. Concrete strengths are typically low, around 15 MPa, and the quality of aggregate is variable, with many projects constructed near the coast using local beach sand and weathered shells. The concrete detailing is typically specified on the architectural plans rather than the structural drawings. Characteristics regarding composite behaviour and the timing of spawling of the concrete encasement is a primary subject area requiring research attention, so that substantially more accurate studies may be conducted on the non-linear strength characteristics of such buildings. Additional aspects requiring research attention include fracture of the rivets in the steel framing, yielding of support brackets in tension and shear, and section failure. The use of beams in two directions in most of these structures presents the critical detail, with particular focus required on the detail connecting beams with columns loaded in weak axis bending as shown in Figure 3. After World War II the popularity of this construction technique declined steadily as reinforced concrete became the preferred material to utilize in large scale design.

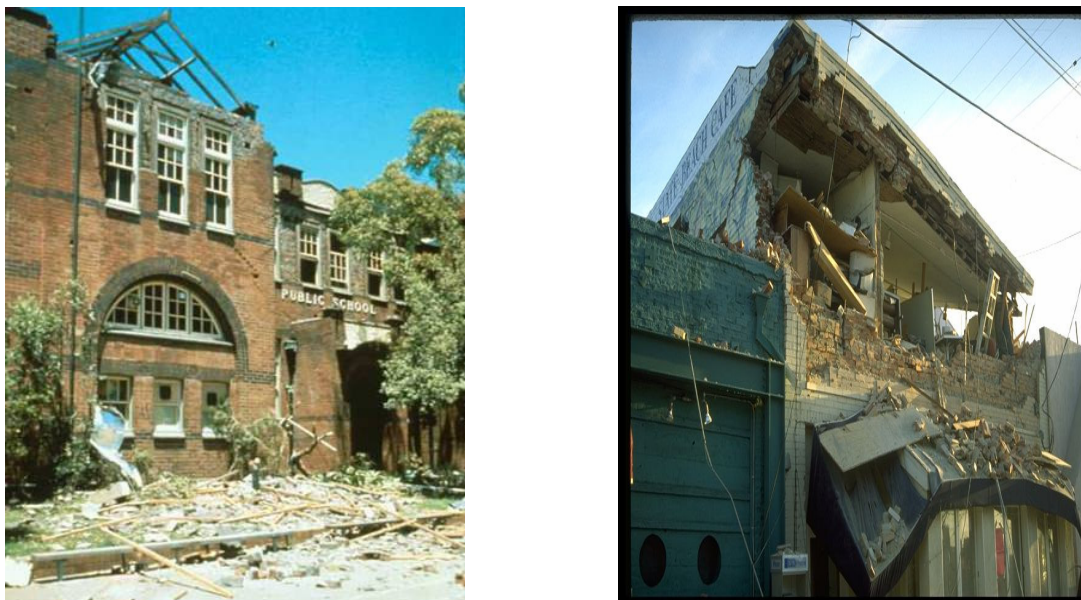
Figure 4 Damage to unreinforced masonry buildings in the 1989 Newcastle earthquake (Australia) (left) and the 1994 Northridge Earthquake (USA) (right)

The configuration of unreinforced brick with timber floors has emerged to be a common and vulnerable system to earthquake loading, where connections between floors and walls are insufficient as well as the strength of the floors themselves. In addition upper floor levels and parapets lack strength and require some method of bracing. Where these buildings contain extensive openings in the form of doors and windows, the wall becomes increasingly vulnerable.

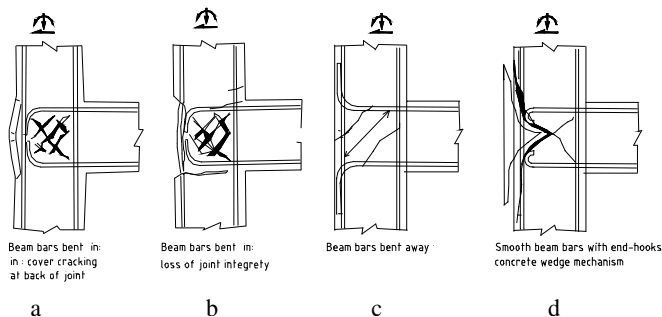
Figure 5. Alternative damage mechanisms for exterior tee-joints: a, b) beam bars bent inside the joint region; c) beam bars bent outside the joint region; d) plain round beam bars with end-hooks: “concrete wedge” mechanism (picture on right side)

As a consequence of poor reinforcement detailing, lack of transverse reinforcement in the joint region, as well as absence of any capacity design principles, brittle failure mechanisms are expected either at local level (e.g. shear failure in the joints, columns or beams) or global level (e.g. soft storey mechanism). As noted in previous studies (Hakuto et al., 2000, Pampanin et al. 2003) different damage or failure modes are expected in beam-column joints depending on the type of joint (exterior or interior) and of the adopted structural details (presence of transverse reinforcement in the joint; use of plain round or deformed bars). Possible damage mechanisms of exterior tee-joints with no transverse reinforcement in the joint region are shown in Figure 5. All of these solutions have been adopted in the past in NZ.

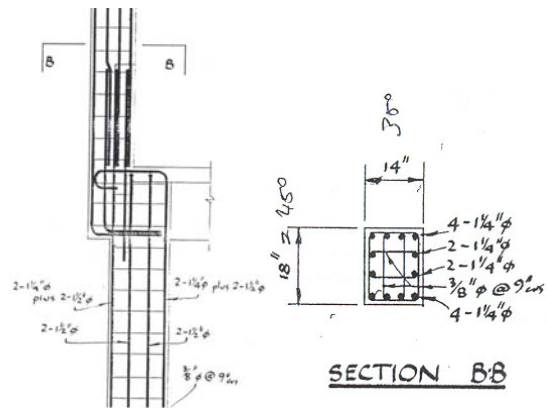
Figure 6. Typical reinforced concrete detail

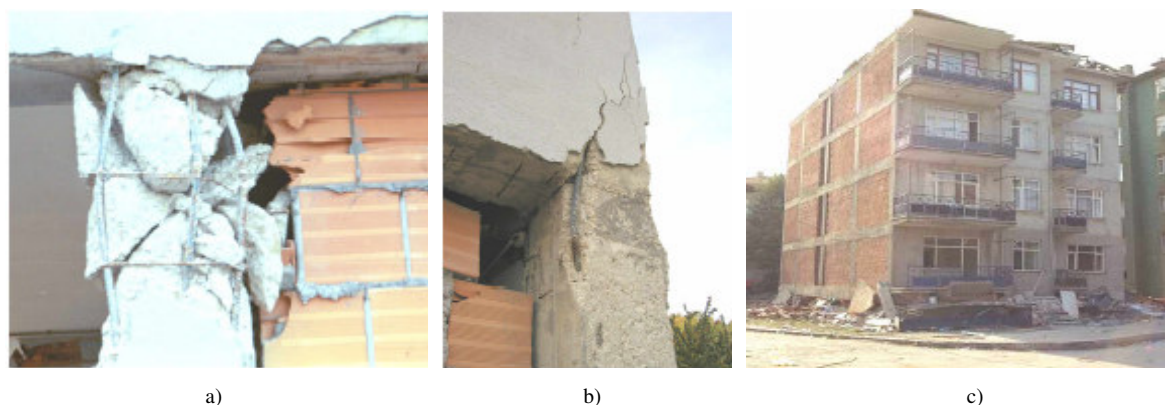
Figure 7 Observed effects of interaction between infills and bare frame: a) shear failure of column and b) exterior joint shear damage (Bonefro, Molise 2002); c) global collapse for soft storey mechanism (Izmit, 1999)

Regardless of the extent of inherent weaknesses in the bare frame systems, the presence of infills (e.g. typically un-reinforced masonry) and their interaction with the bare frame, can lead to unexpected and controversial effects (Crisafulli et al., 1997). The effects of infills still represent an open topic, with a critical need of further investigations for the seismic vulnerability assessment of extensive classes of existing buildings.

The presence of infills can allow higher stiffness and strength, reducing the inter-storey drift demand, while increasing the maximum floor accelerations. A further protective action of the infills can be recognized in the reduction of column interstorey shear contribution as well as in the possible delay of a soft-storey mechanism which might instead develop in a bare frame solution. However, the sudden reduction of storey stiffness due to the damage of the infills can still lead to the formation of a soft storey mechanism, which, due to the interaction with joint damage, can occur any floor level and independently of the distribution of the infills along the elevation (Pampanin, 2005). Furthermore, shear failure in the column, due but not limited to short column effects, can result. Similarly, when investigating the response of 3-D frames under either uni-directional or bi-directional earthquake input excitation, inelastic torsion mechanisms can occur due to the irregular distribution of damage to the infills.
